Joint Investigation Summary of a Fire Engine Rollover

**Fire Engine Rollover
July 1, 2004**

**Kirker Pass Fire
CA-SCU-003601**

CA-CNR-000029

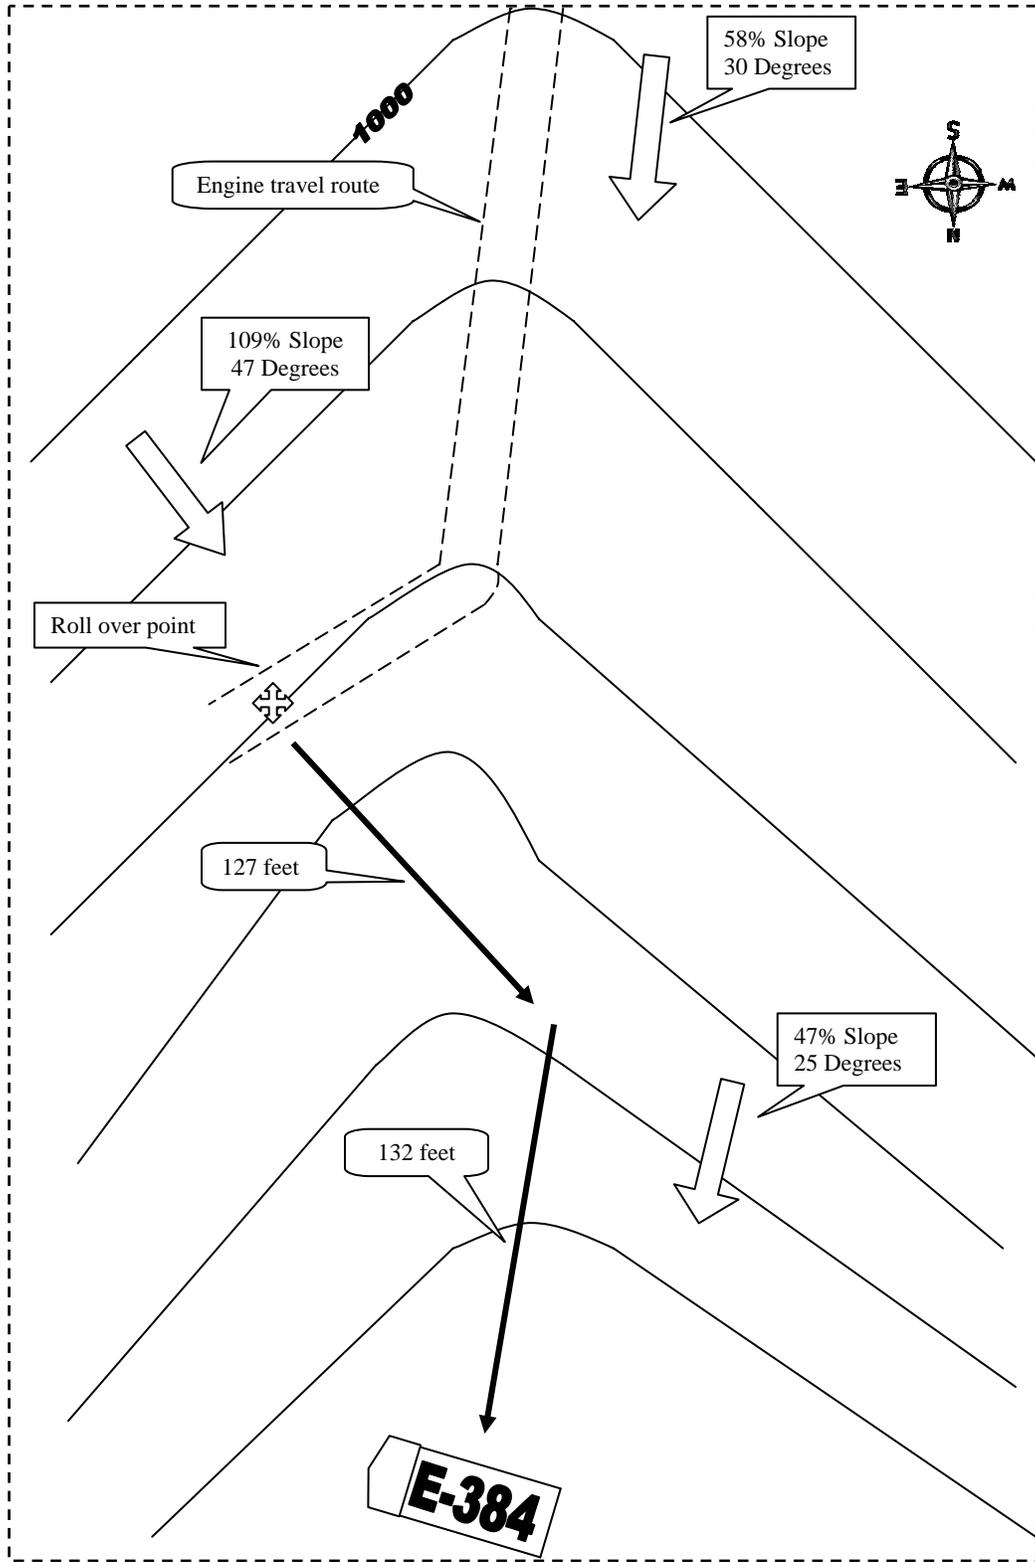
In an effort to bleed off speed, Engineer 384 turned the engine approximately 30 degrees to the right, climbing up the right side of the draw. This action placed the engine on a side slope of 109% (47 degrees). As the engine rolled to a stop, he applied the service brakes to avoid rolling backward. Within seconds, as water shifted through the tank baffles, the engine began a slow roll onto the left side, completing six revolutions over 259 feet before it came to rest on the driver’s side.

MAP 1. Descent and rollover paths of E-384.
