SUBJECT : SAFETY BULLETIN : Tuolumne Fatality - 72 Hour Report and Supporting Documents

CDF HELITACK 404 CREW BURNOVER

September 12, 2004

**TUOLUMNE FIRE
CA-STF--2191
STANISLAUS NATIONAL FOREST**

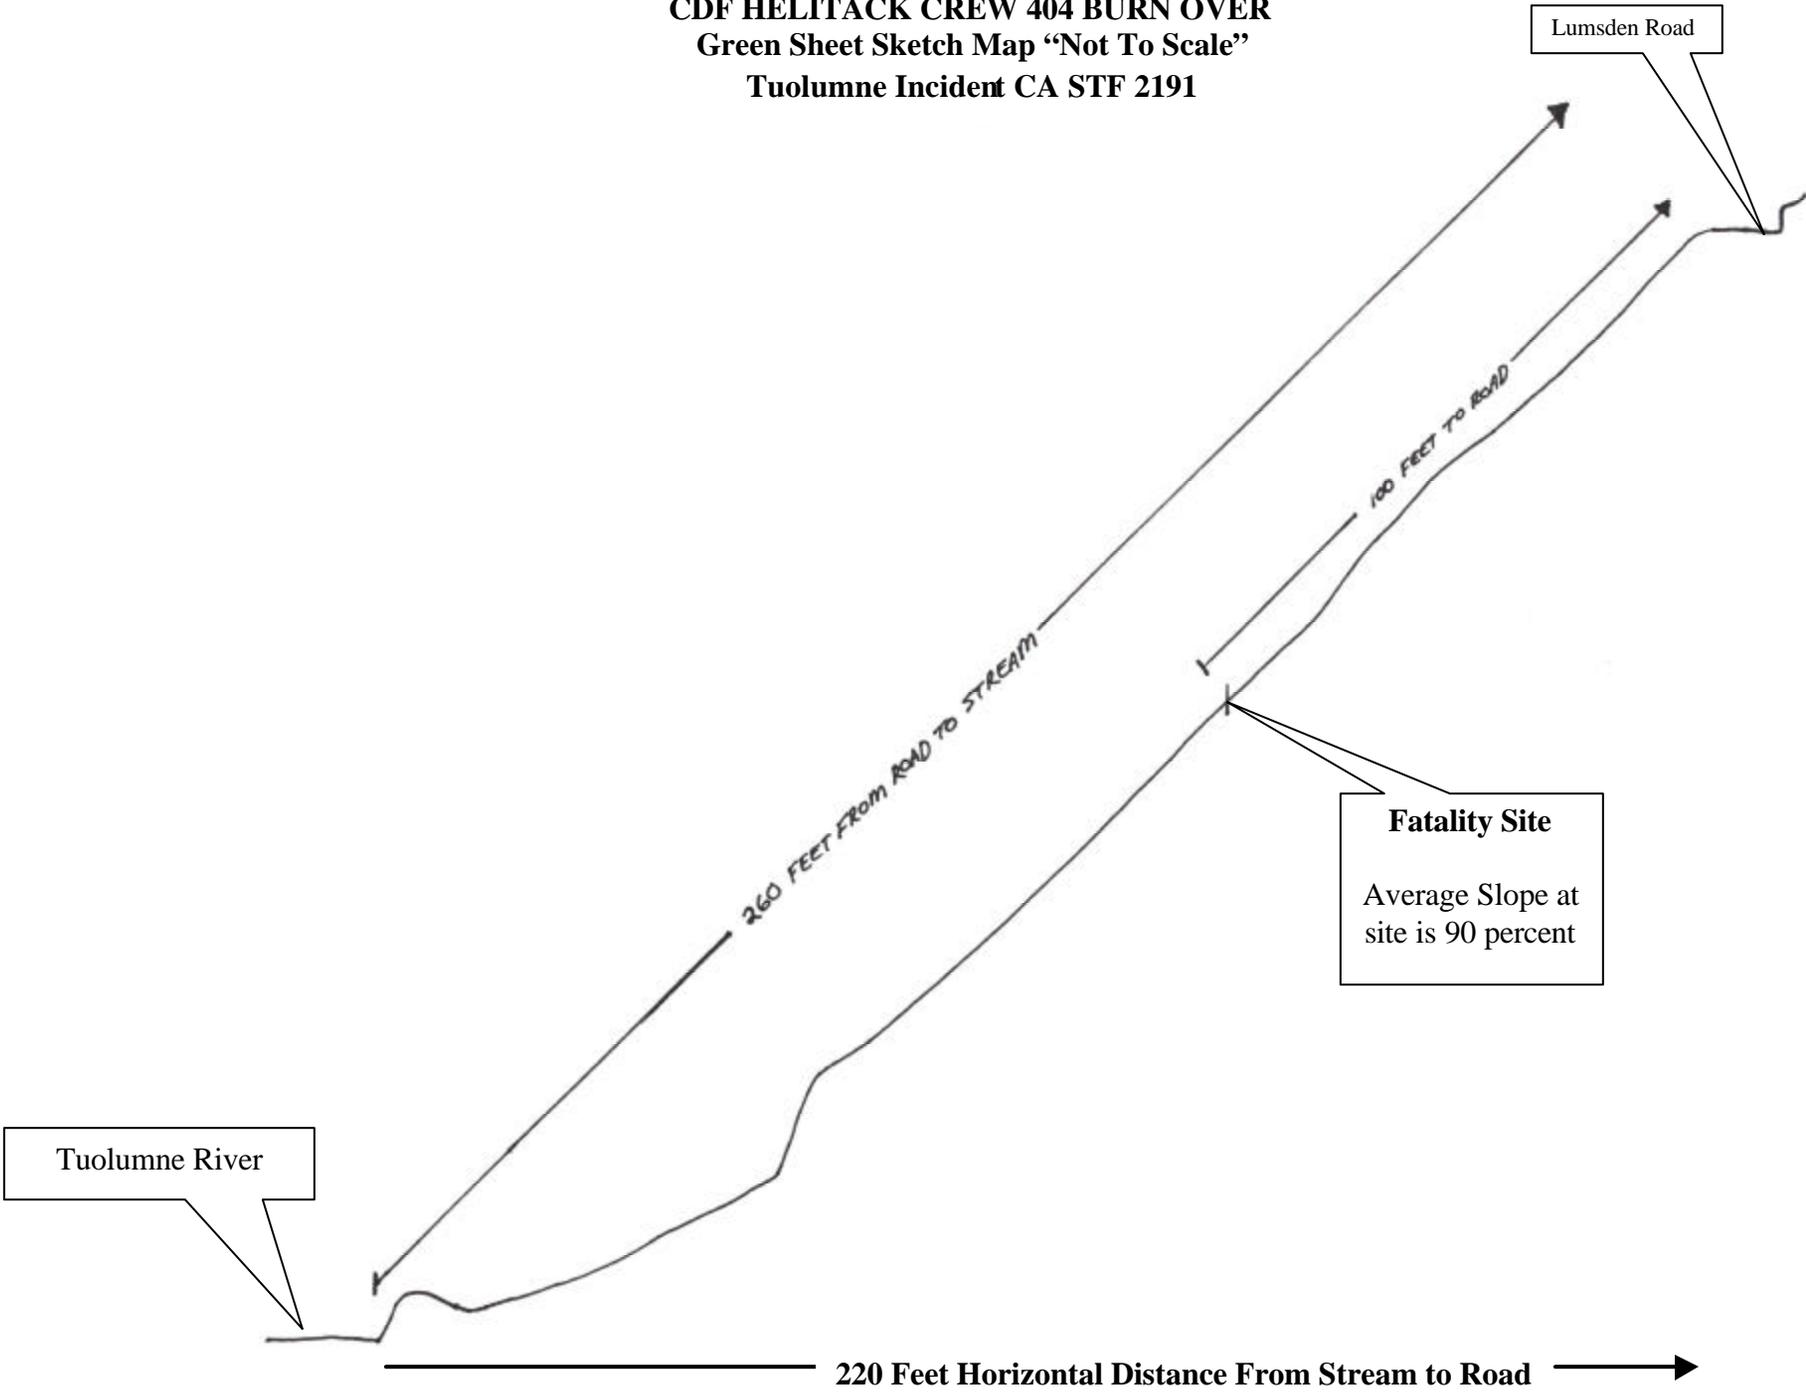
CDF HELITACK CREW 404 BURN OVER
Green Sheet Sketch Map "Not To Scale"
Tuolumne Incident CA STF 2191

Fatality Site
Average Slope at site is 90 percent

260 FEET FROM ROAD TO STREAM

100 FEET TO ROAD

220 Feet Horizontal Distance From Stream to Road
