In-Flight Action Award David Fennen

Reference: SAFECOM 19-0351

Tracking #: 19-0351

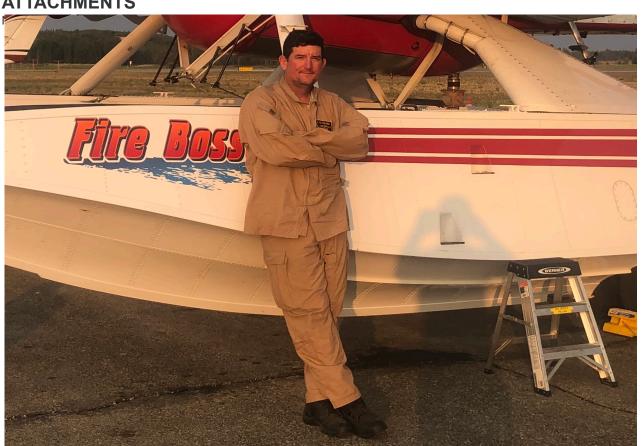
During the fourth scoop the Fire Boss scoops failed to retract causing the tank to fill to max capacity subsequently blowing out the top which reduced forward visibility out the windscreen to zero. The PIC immediately activated the emergency dump system and jettisoned the load. As later determined during post-flight maintenance inspections, the scoops could not retract due to a mechanical issue. Therefore, during the scoop abort, visibility was not regained as would normally occur immediately after jettisoning the load once the scoops retracted. The PIC then selected max power and successfully accomplished a water takeoff. The PIC then aborted the mission and returned to Fairbanks for maintenance. BLM AV Safety, WS, 7/23: Scoops remained down after jettison of load and continued to fill causing visibility issues, after the water takeoff visibility improved out the windscreen. Excellent situational awareness by the pilot.

Inspect scoops to determine cause of scoop retraction failure. BLM AV Safety, WS,7/23: The mechanical issue turned out to be a faulty hydraulic Vickers valve which was replaced by the mechanic. Operations checks were positive and OAS inspector returned the aircraft to contract availability on 7/18.
