Executive Summary

On Sunday, September 14, 2014, a Bell 206L-1 (NXX) contractor owned and operated aircraft was involved in a mishap while conducting a fire suppression operation approximately 50 nautical miles south of Burns, Oregon. The fire suppression mission was in response to a scheduled prescribed burn for the Moon Hill RX that exceeded the set boundary (although within the designated project area). The mission was under the operational control of the BLM.

Bureau of Land Management, Incident-With-Potential, NXX
Burns, OR.

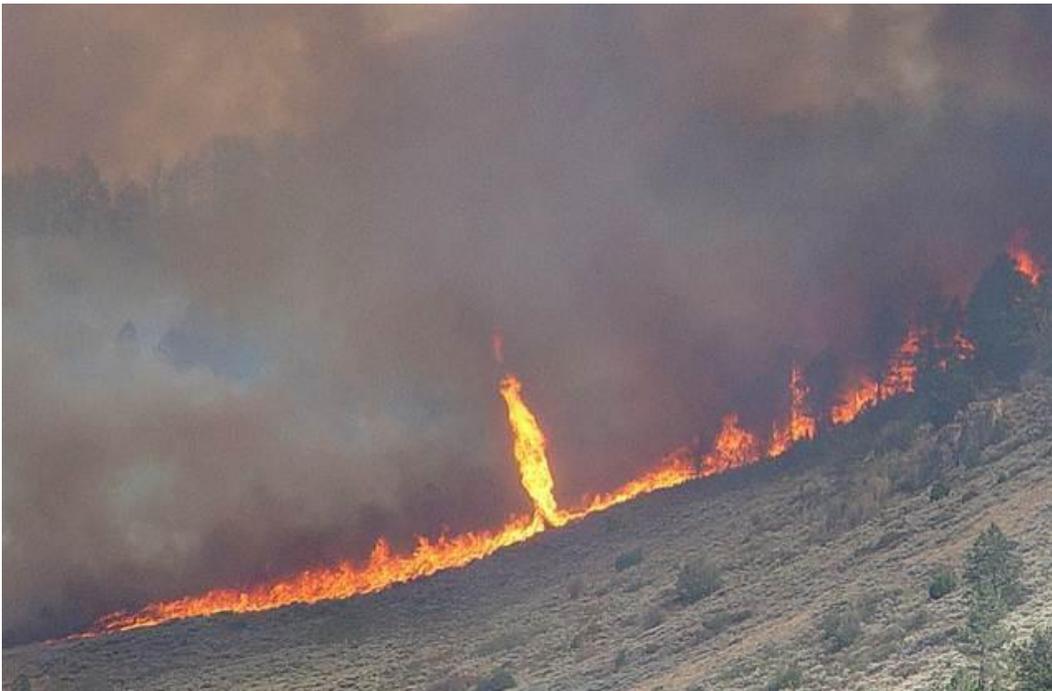
Figure 7. Representative photo of a fire whirl approximately 40- 50 foot tall.

Real-world fire whirls (Figure 7) usually move slowly. Fire whirls can set objects in their paths ablaze and can hurl burning debris out into their surroundings. The winds generated by a fire whirl can also be dangerous. Large fire whirls can create wind speeds of more than 100 mph strong enough to knock down trees.

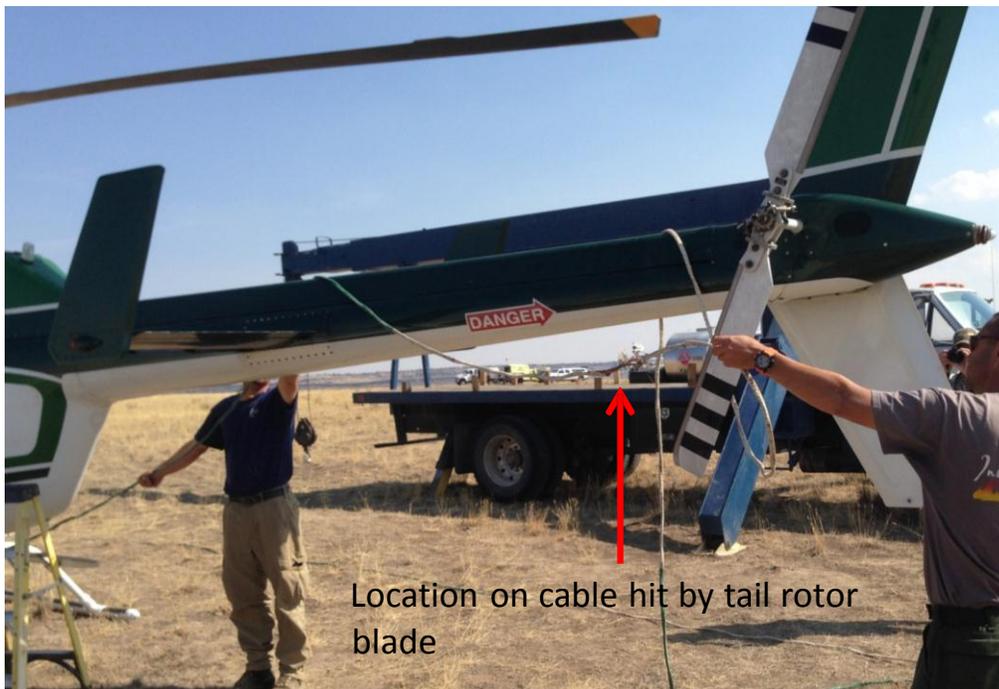
Figure 8. Re-enactment of the cable wrapped around the tailboom.

According to the pilot, the cable came up in front of the right horizontal stabilizer, went over the tail boom and behind the left stabilizer (figure 8). There were no witnesses to the event.

Media – gusting winds resulting in the formation of a fire whirl was a contributing factor in this mishap

1. OAS Training develop a training module on fire tornados and the potential impact to flight operations. Include “best practices” procedures for encountering a fire whirl.
2. BLM reiterate the importance of reviewing PASP that are more than one year old to review and document any changes that might be required.
3. OAS Aviation Safety develop a Lessons Learned Publication to alert all aviation personnel on the dangers of fire tornados.
