# Interagency Aviation SAFETY ALERT

No. IA SA 16-01

**Subject:** AS350 Family Tail Rotor Bellcrank

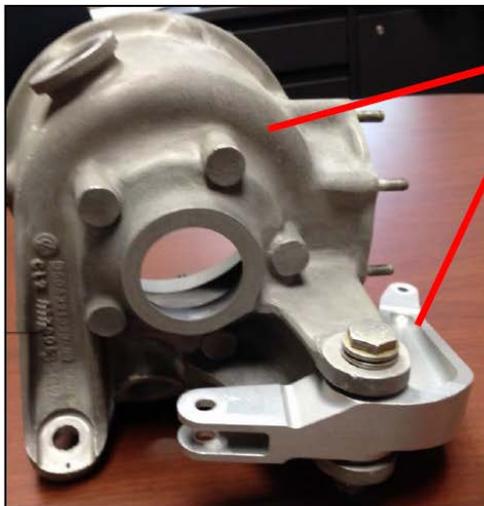
Figure 1 Example gearbox and bellcrank

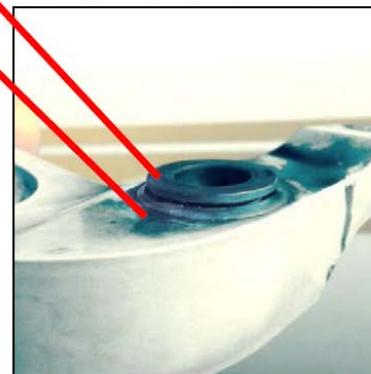
[SAFECOM 15-316](#) was submitted on June 22, 2015. The submitter identified the bellcrank bushing had slipped out of its position. The bellcrank was replaced and in less than 10 hours had failed again.

[SAFECOM 15-605](#) was submitted on August 14, 2015. A pilot was conducting a preflight inspection of his aircraft and noticed that the bushing had slipped. The bellcrank was replaced and after 3 hours of flight time, slipped again. The pilot of this aircraft had read [SAFECOM 15-316](#) which made him aware of this issue and focused greater attention to the bushing on the bellcrank.

Figure 3 Actual bushing failure showing gap

OAS maintenance inspectors have reviewed these cases and are encouraging an increased focus in this area during pre-flight and post-flight inspections.
