Elevated SAFECOM 14-0270 [Helicopter]

Summary from SAFECOM submission:

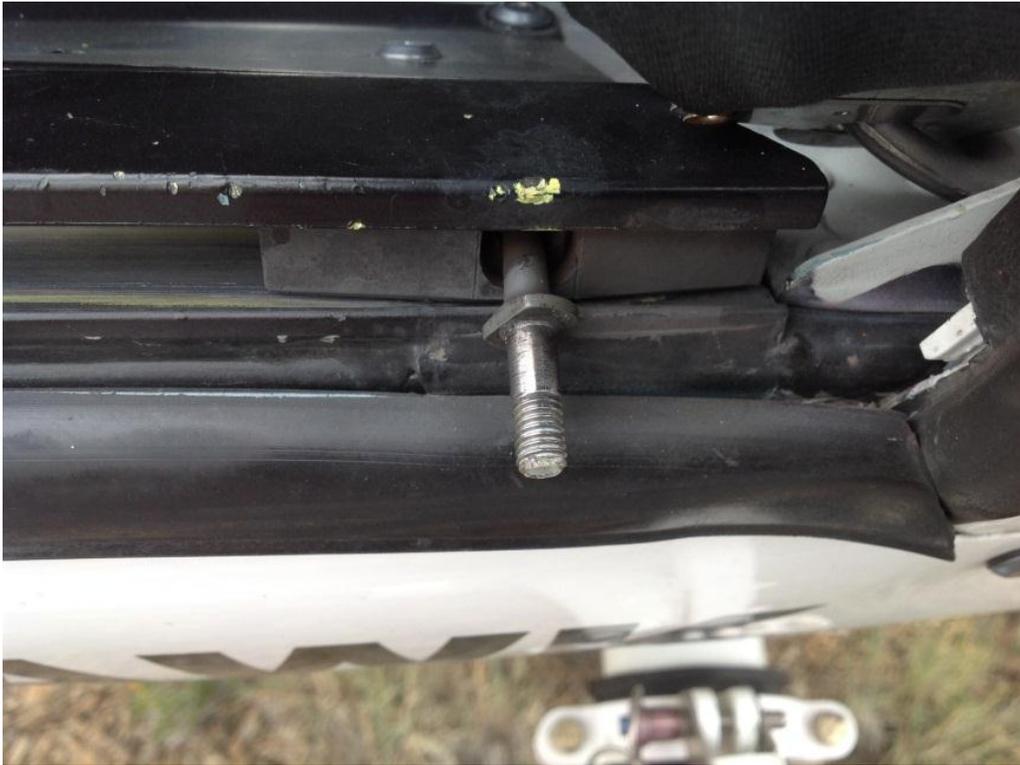
The lower ball-joint bolt assembly that retains the aft sliding door appears to have little evidence of damage. Neither the track, the rail, nor the ball-joint retaining block appears to have been pulled by excessive force.

Figure 1 Ball-Joint Bolt in lower door slide remained in place after door fell off aircraft.

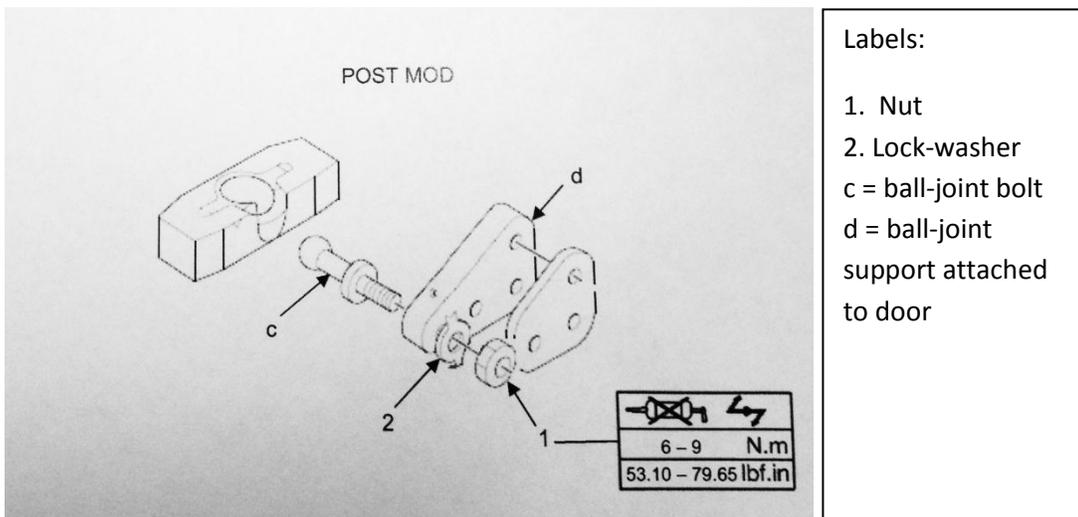
There are two Airworthiness Directives (AD 2013-23-9 and AD 2013-08-19) associated with this aircraft concerning the sliding doors. Logbook entries and witness interviews support the contractor's claim that they had complied with the requirements. The AD 2013-23-9 which addressed the lower ball-joint nut and washer was completed at the factory prior to aircraft delivery. The AD was released in 11/22/2013 and the contractor verified that the modification (Modification AL 4262) was completed on the aircraft (Figure 2).

Figure 2 Post Modification Ball-Joint Assembly specified by AD 2013-23-9

1. Nut
 2. Lock-washer
- c = ball-joint bolt
d = ball-joint support attached to door

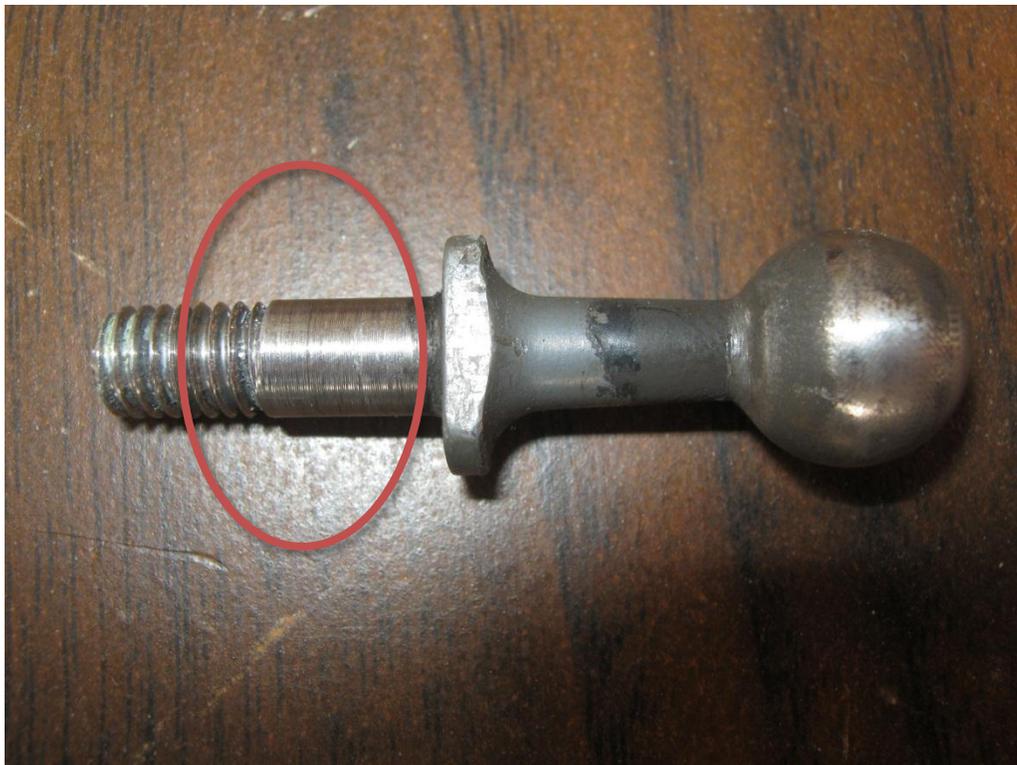
The condition of the threads and the surrounding components points to fact that the self-locking characteristics of the nut of the ball-joint bolt were lost. The nut backed off with aircraft vibration and allowed the door to become loose and become detached from the aircraft. The ball-joint bolt showed signs of rotational scoring (Figure 3) on the shaft of the bolt that came in contract with the door flange. Maintenance manuals specify proper torque requirements to prevent the ball joint from rotating and the potential for the nut to back off..

Figure 3 Ball-Joint Bolt showing rotational scoring

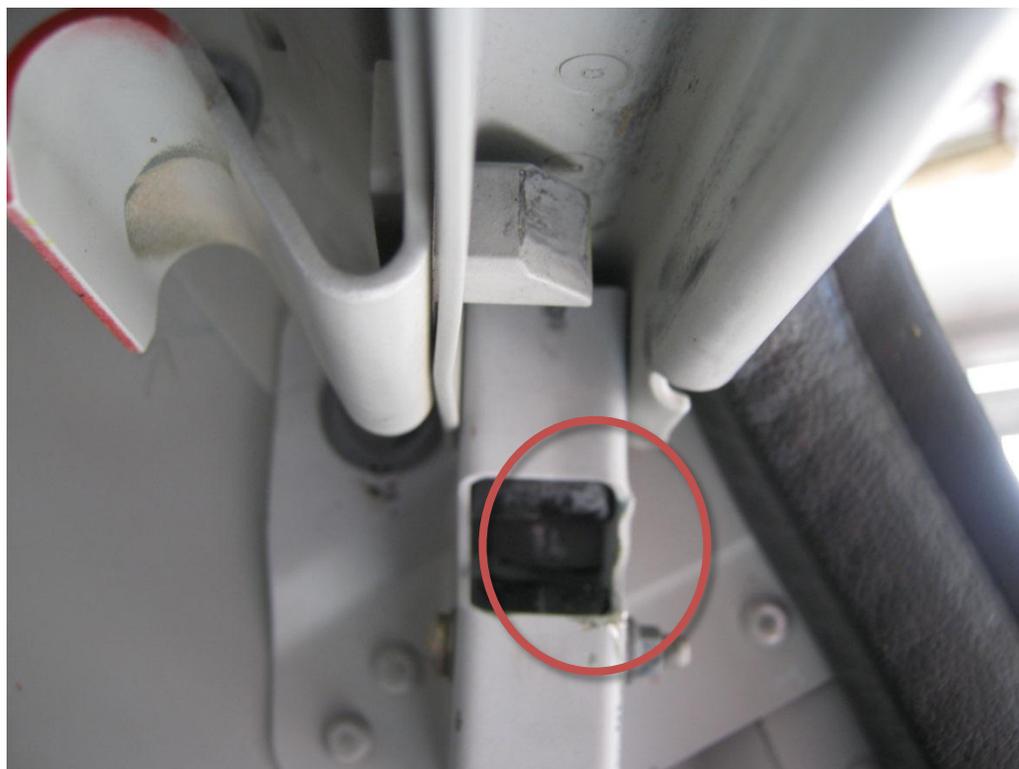
The Helicopter manager, who was in the helicopter at the time of the incident, stated that the left cabin sliding door was secure in its open and locked position. Locking the door back provides additional support for the sliding door. The rear locking assembly appears to have been deformed indicating sideward force on the locking mechanism as the door was pulled left and it departed the aircraft with the failure of the ball-joint bolt.

Figure 4 Left Sliding Door Lock Assembly showing deformation

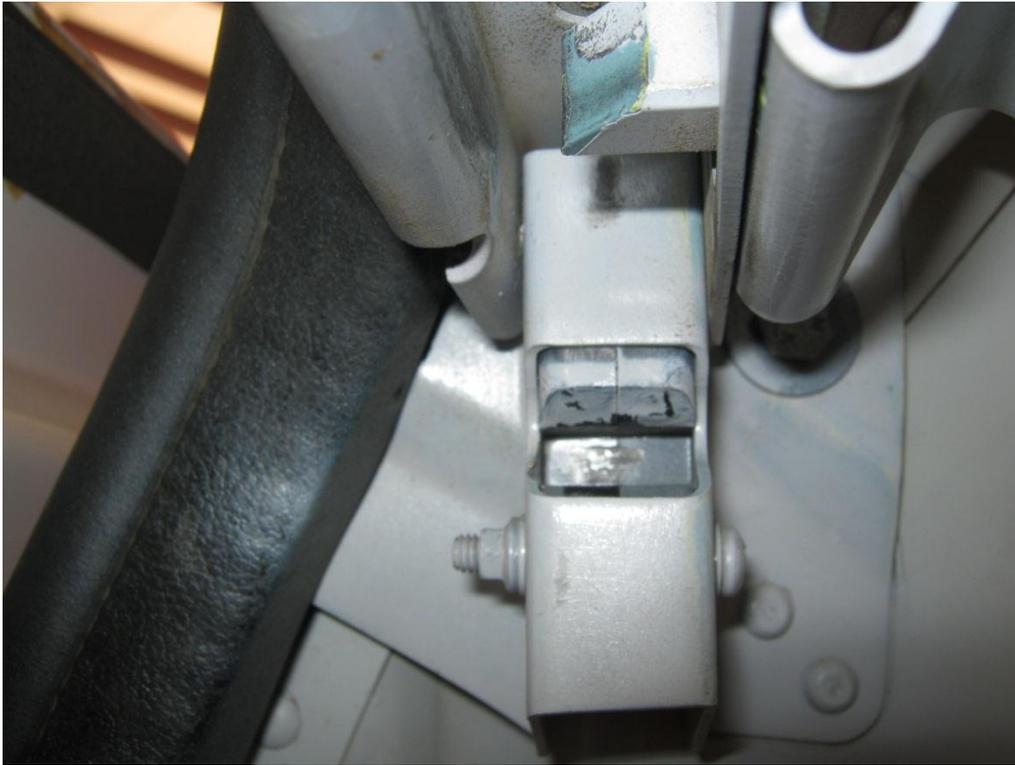
Figure 5 Right Sliding Door Lock Assembly with no deformation.

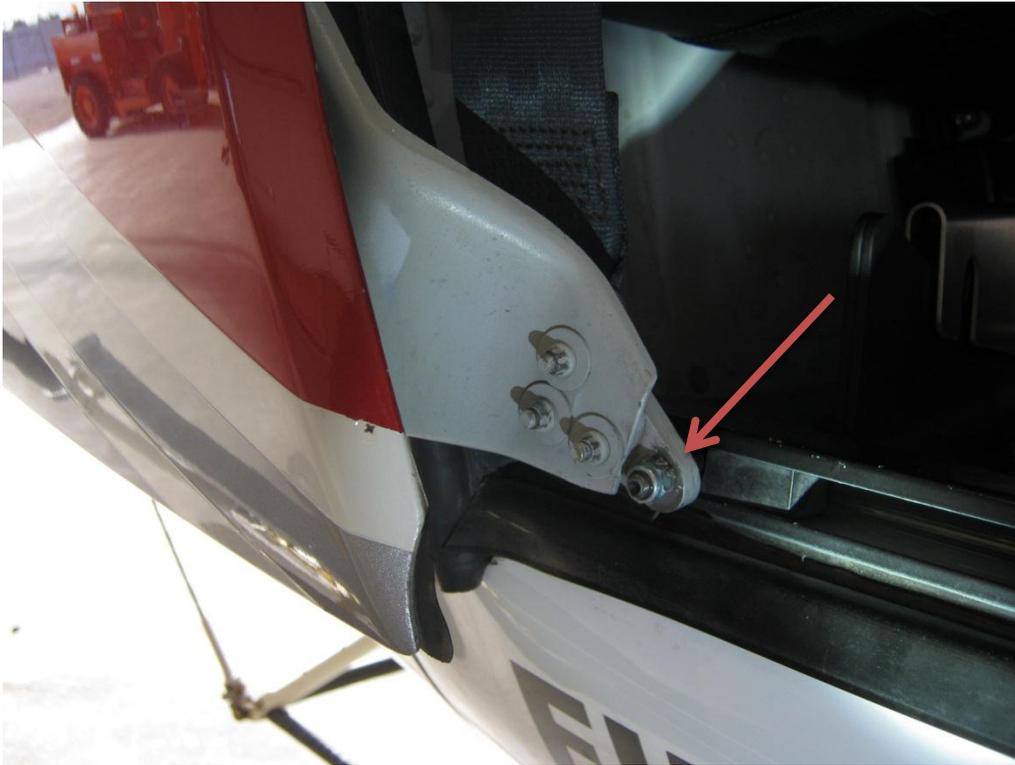
The primary security for the sliding door assembly on this model of helicopter rests on one fastener. Reviewing the bolt and the overall door assemblies on this helicopter, the evidence points to the failure of ball-joint bolt and nut. This fastener should receive increased focus on daily and periodic inspections to ensure that the door stays securely attached to the aircraft. It is readily visible every time the door is open and should be inspected often.

Figure 6 Ball-Joint Bolt and Nut are clearly visible when door is open

OAS Safety to issue Lessons Learned bulletin emphasizing the importance of proper installation of the ball-joint bolt, lock-washer, and nut; increased focus for daily and periodic inspections; ensuring the all crewmembers use CRM to ensure doors are secured in position; and to remind pilots to review airspeed limitations for open door configurations.
