Balance Rock Accident Investigation Team

Accident Investigation Factual Report Balance Rock Rollover Engine E2421

Bureau of Land Management
Twin Falls District, Idaho

August 21, 2006

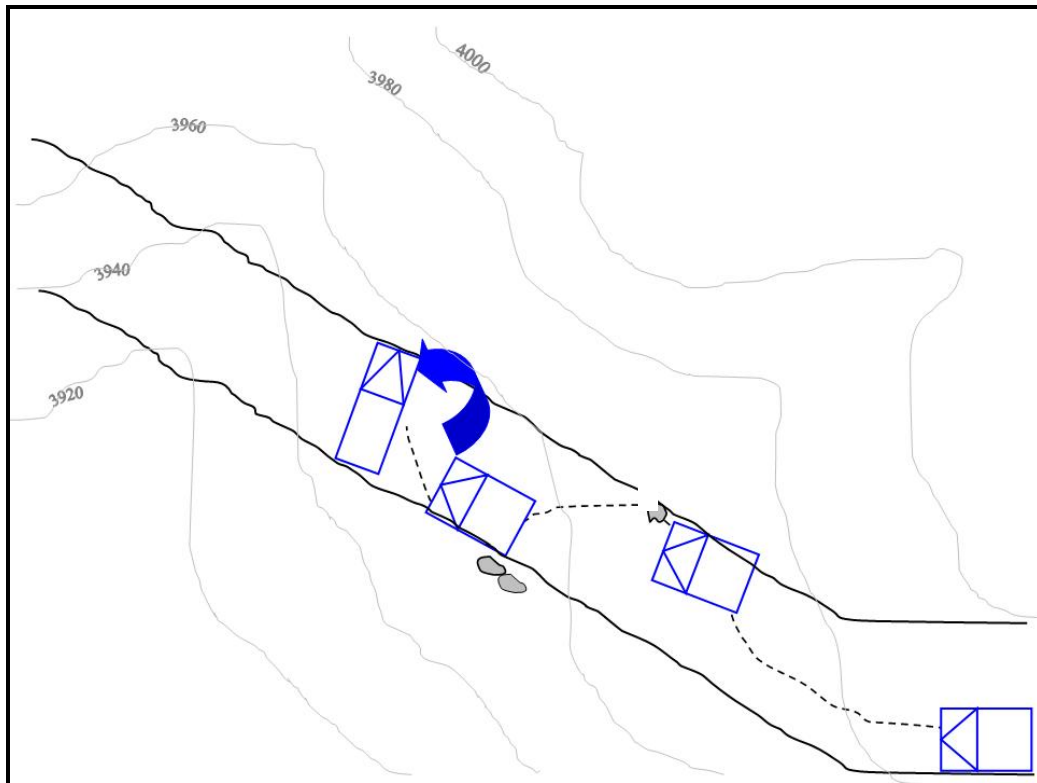
In an attempt to avoid impacting the rocks along the left side of the road, the operator then applied the brakes, and steered to the right, back towards the road. After impacting one large rock with the driver side rear tire, the engine began to lean to the driver side and then made a three-quarter roll. The engine then came to rest on the passenger side lying perpendicular in the road (See Sketch and Photo 1 below).

**Photo taken by County Sheriff of E-2421, after accident.
Note a portion of the Cab has been cut open to extricate trapped occupants**

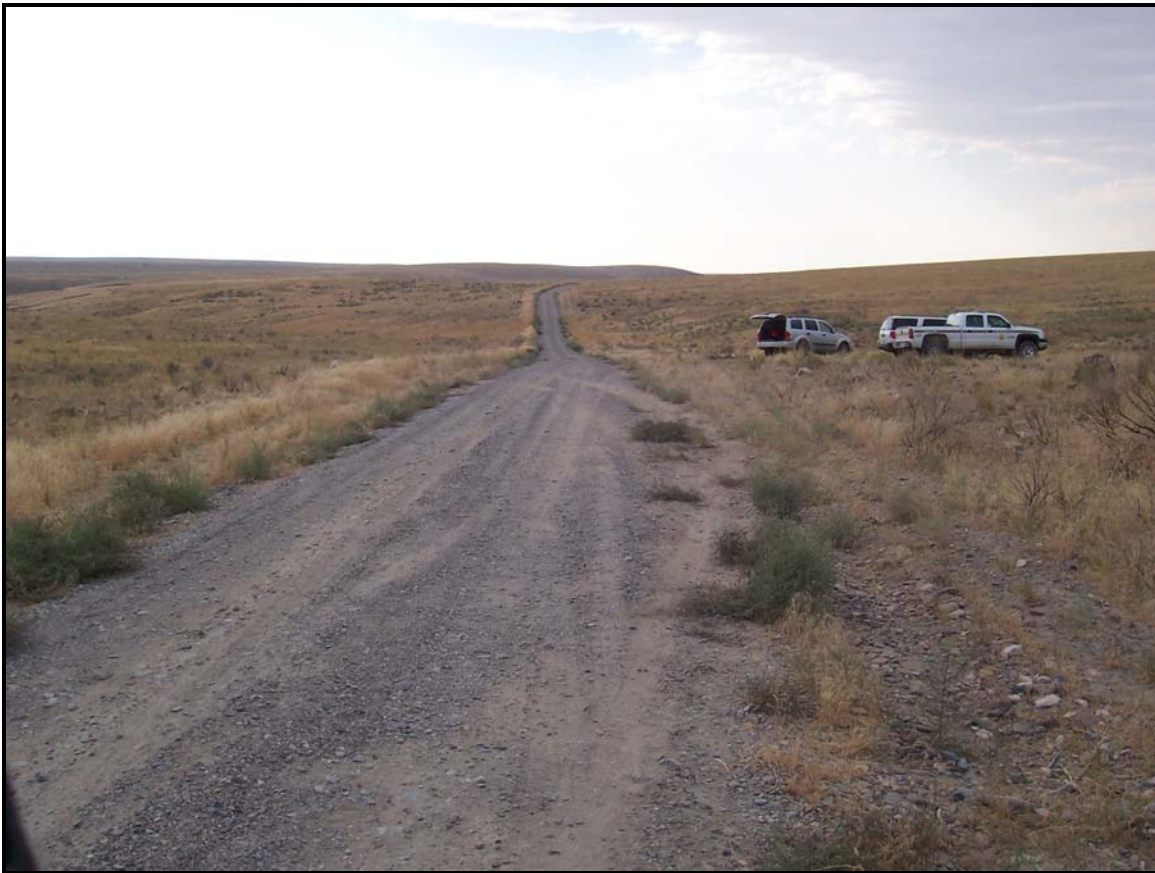
Investigation of the accident site confirmed that the wheel tracks from E2421 are consistent with the engine operator’s statement on when the engine began to “fish tail,” and eventually left the road (see Photo 2 below).

**Photo is looking west along the Balance Rock road;
note the “fish tail” tracks on the right side of the road left by E2421.**

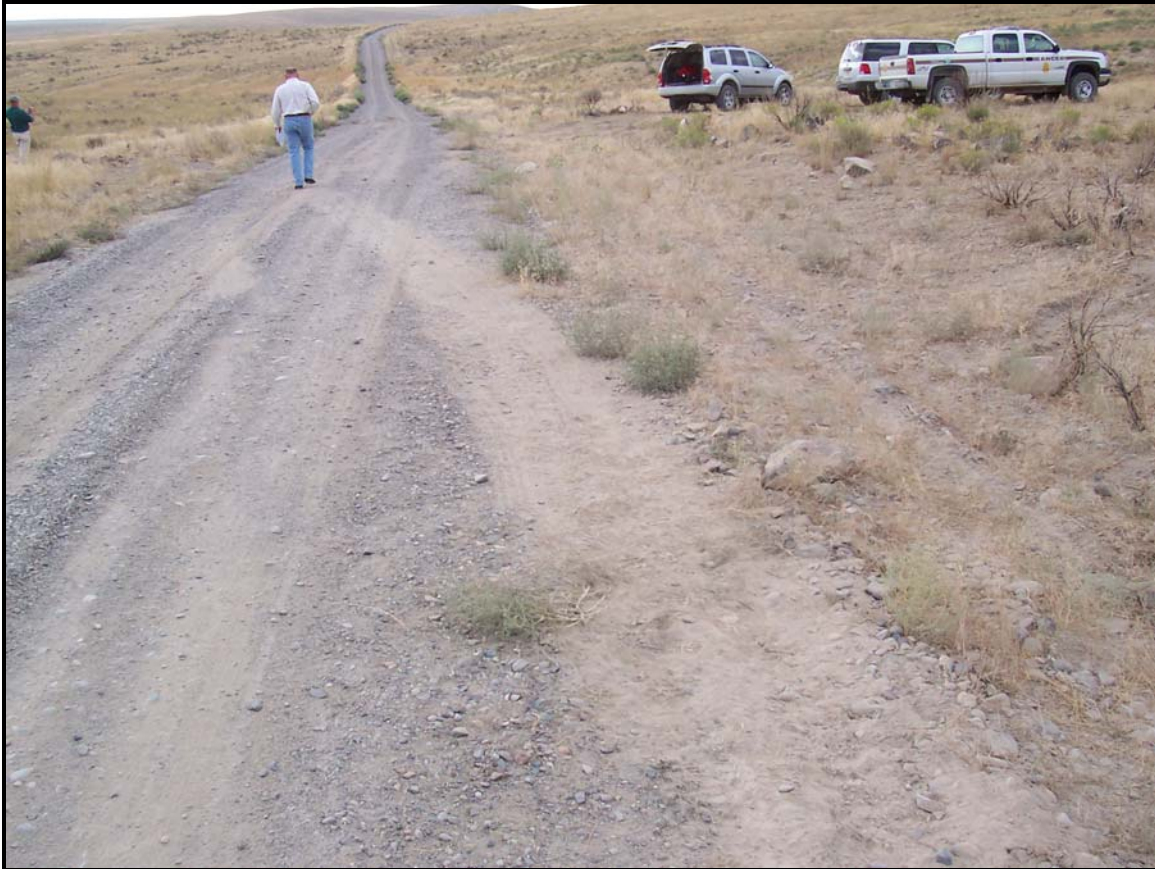
As the Engine “fish tailed” to the right the Operator overcorrected, and as Photo 3 shows, the engine then departed the road bed on the left side of the road.

“Fish tail” tracks from E-2421, where the Engine begins to leave the roadbed near to where the investigator is walking.

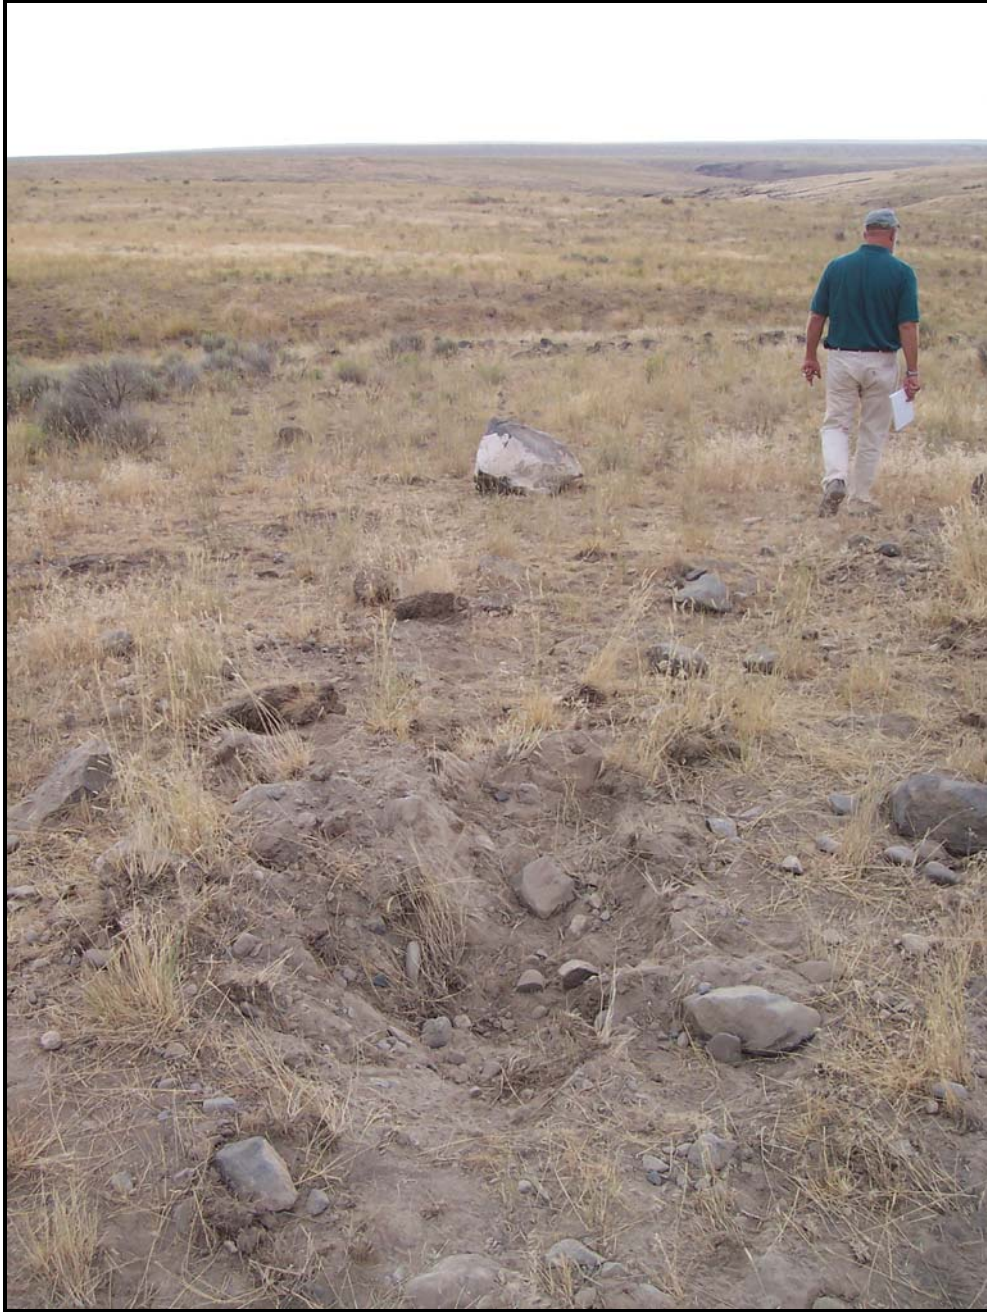
Photo 4

When the Engine left the road bed, the operator attempted to regain control of the engine and avoid a group of rocks. Unable to avoid the largest, the rear of the engine impacted that rock, causing damage to the rear driver side tire rim. This impact also dislodged the rock from its location and caused it to roll approximately 20 feet away (see Photos 4 and 5 below).

**Photo of the hole made when rock was hit and moved.
The large rock is in the center of the photo, just to the left of the investigator.**

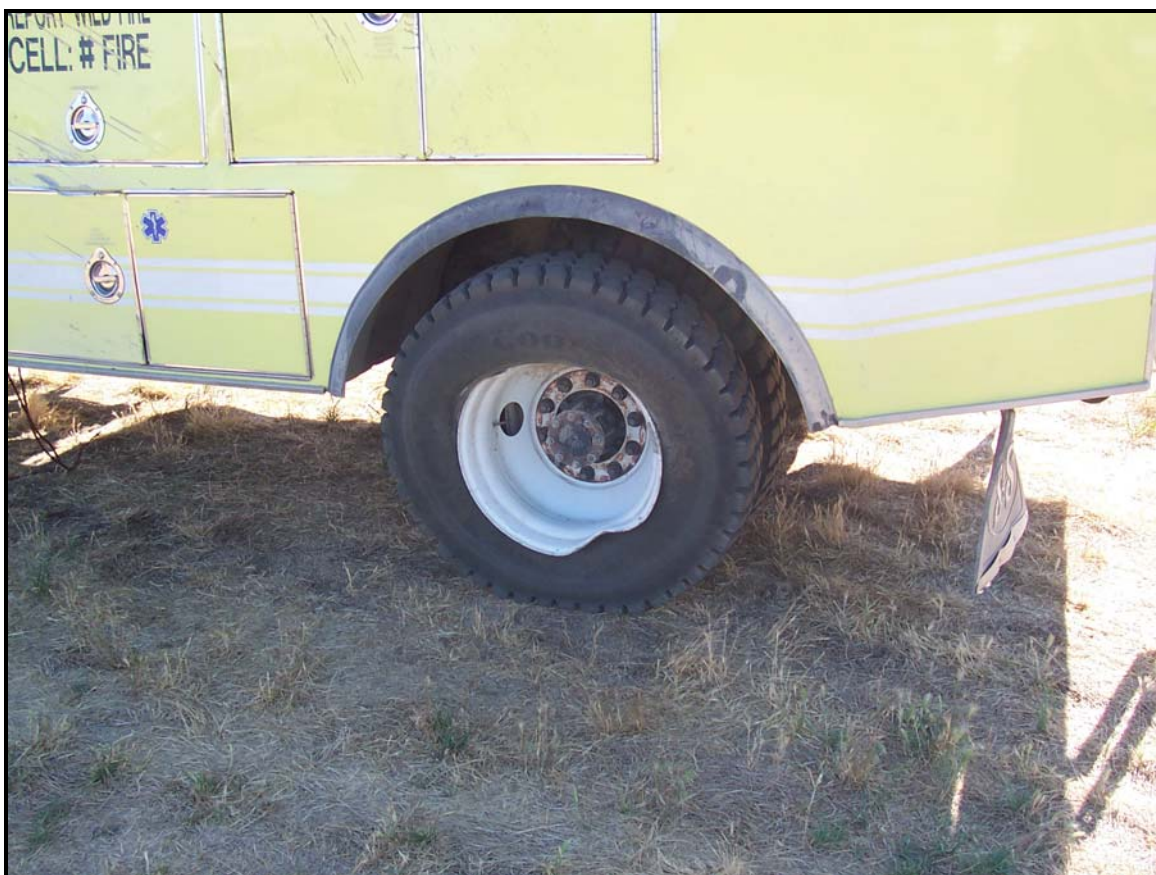
Photo 5

Photo of rear tire rim that impacted the rock.
