Rapid Lesson Sharing

Event Type: Burn Damage to Engine

Date: July 31, 2017

Location: Pole Creek Fire, Nevada

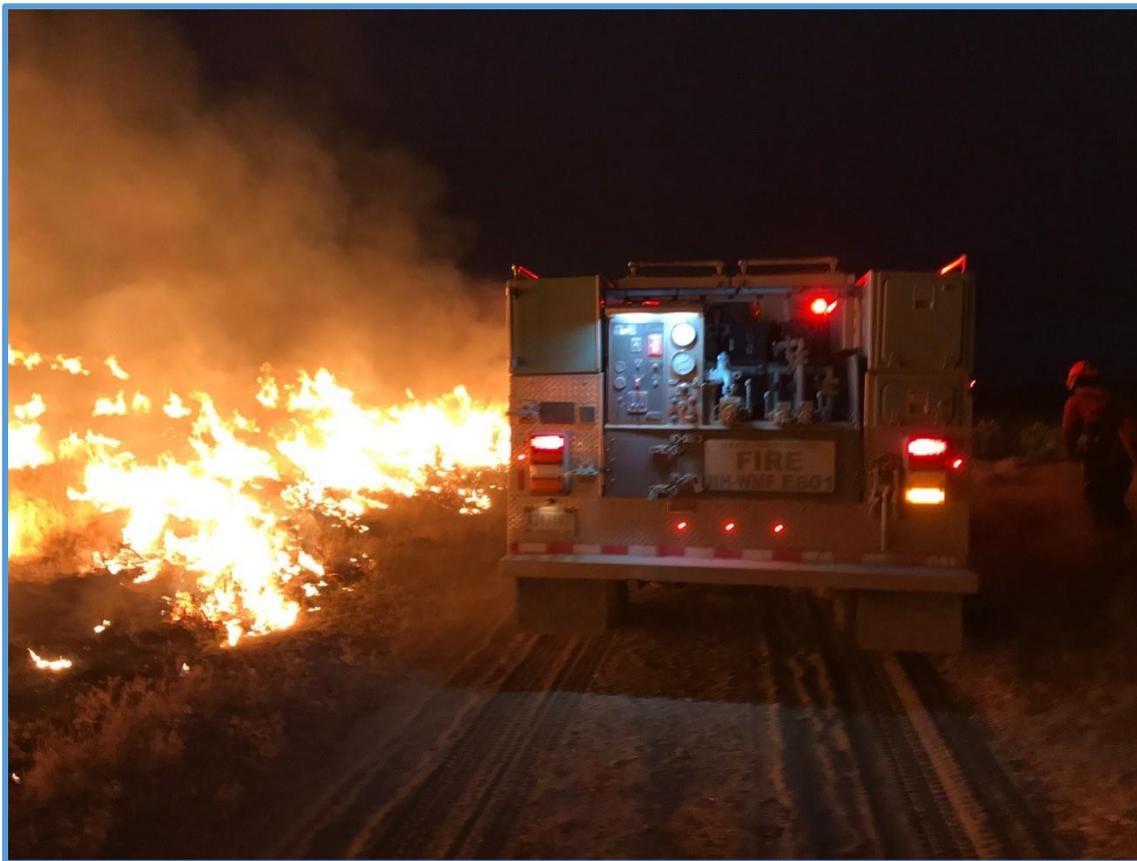
Fire behavior beside Engine E601 during the burn out operation.

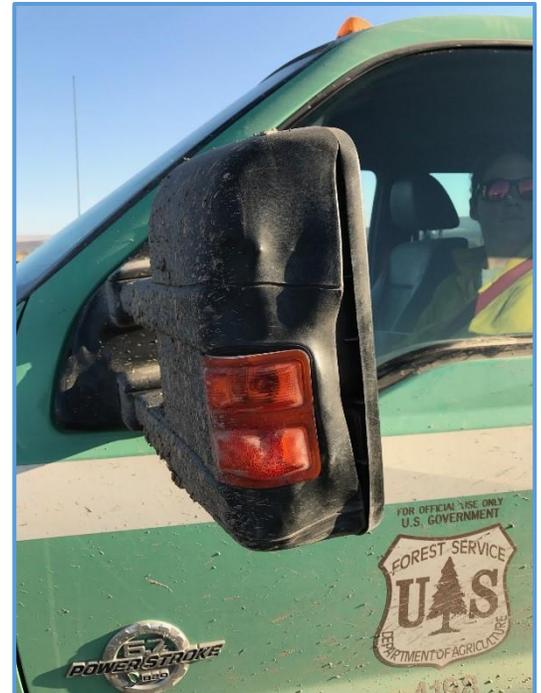
The morning after the operational period, during the daily PM check, E601's crew members noticed scorched decals and a melted driver's side mirror on the engine. It was determined that this damage likely occurred during the burn out operation when the visibility had been poor for that one-half hour time period.

Radiant heat damage to driver's side mirror on E601.

Take a tactical pause to make sure all resources understand and are comfortable with operations. Know the limits of your equipment and your personnel during operations.
