# Crescent Fire Scald Injury

## Facilitated Learning Analysis

Plumas National Forest

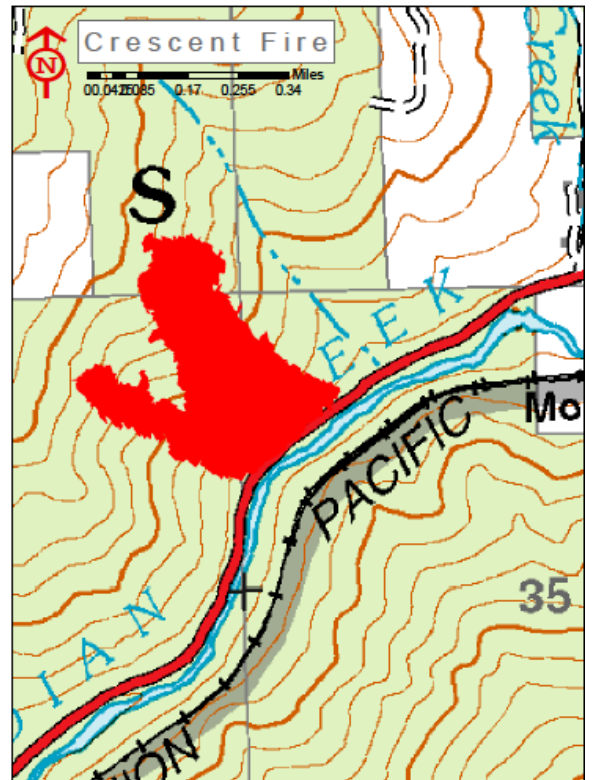
Information gathered at the scene of the fire indicate the total hose lay was approximately 1,000 feet+, with a rise in elevation of 734 feet, and approximate head pressure of 368 psi.

Crescent Incident N120 56.887 X W40 4.277.  
See a Google image of the hose lay and an elevation gain graph on the next page.

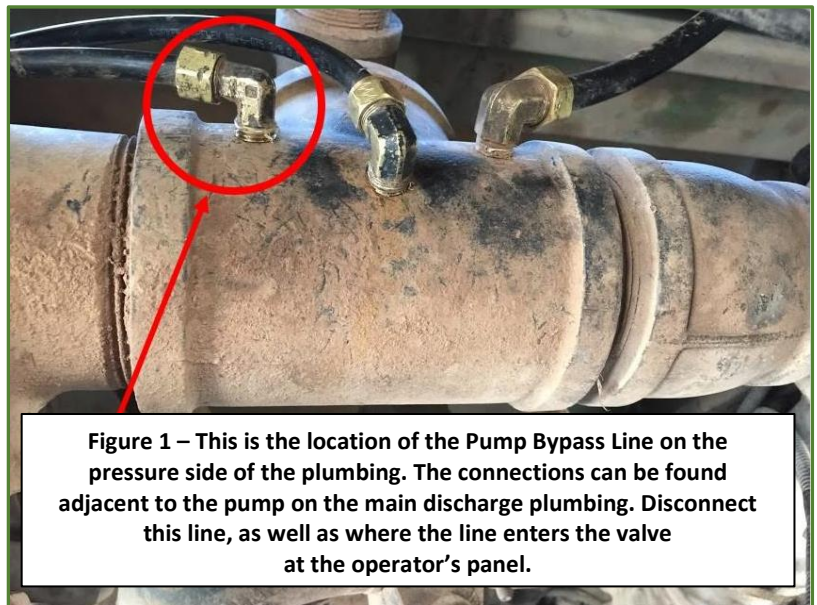
An obstruction in the pump bypass line on the Region 5 Type 3 Model 62 fire engine did not allow for adequate water flow through the line during the pumping operations. This condition led to the excessive heating of water sufficient to sustain burns. This problem with the pump bypass line was identified during the Facilitated Learning Analysis equipment evaluation.

**Figure 1 – This is the location of the Pump Bypass Line on the pressure side of the plumbing. The connections can be found adjacent to the pump on the main discharge plumbing. Disconnect this line, as well as where the line enters the valve at the operator's panel.**

1. Check the #17 pump bypass valve for obstruction. Inspect water flow through the pump bypass line by engaging the pump, opening the tank to pump valve (#1), closing the pump to tank valve (#2), opening the pump bypass valve (#17), and closing all other valves. Run the pump up to 400 psig and visually check the water flow at the line's return point at the top of the tank. The return point should be located near the tank tower on top of the engine. Water flow at the return point should be a fairly strong stream of approximately 6 gpm.

2. Disconnect the pump bypass line from the pressure side of the plumbing (see Figure 1) and the valve at the operator's panel (see Figure 2). Once the line is disconnected, clear the line with pressurized air using an air compressor (shop pressure between 90 – 100 psi).

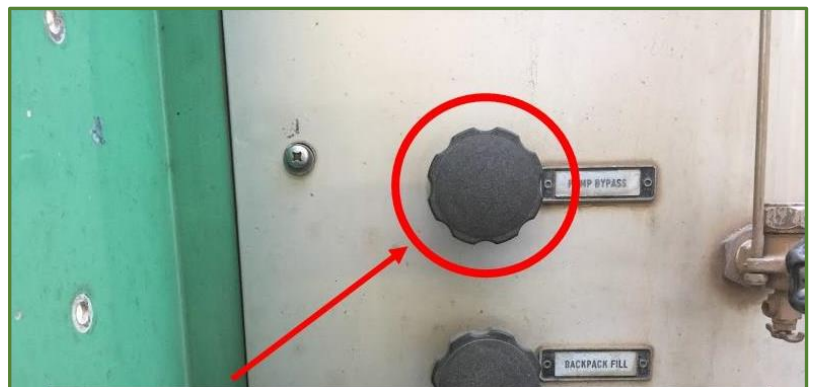
**Figure 2 – The location where the Pump Bypass Line enters and exits the valve is behind the control knob on the operator's panel. Disconnect both the entering line and the exiting line. Once the Pump Bypass Line has been disconnected in the described three locations, apply pressurized air from a compressor. The pressurized air should be applied to both the line of the disconnected lines.**
