Redwood Engine 30 Vehicle Fire

Non-Serious Accident Investigation

Lessons Learned Review

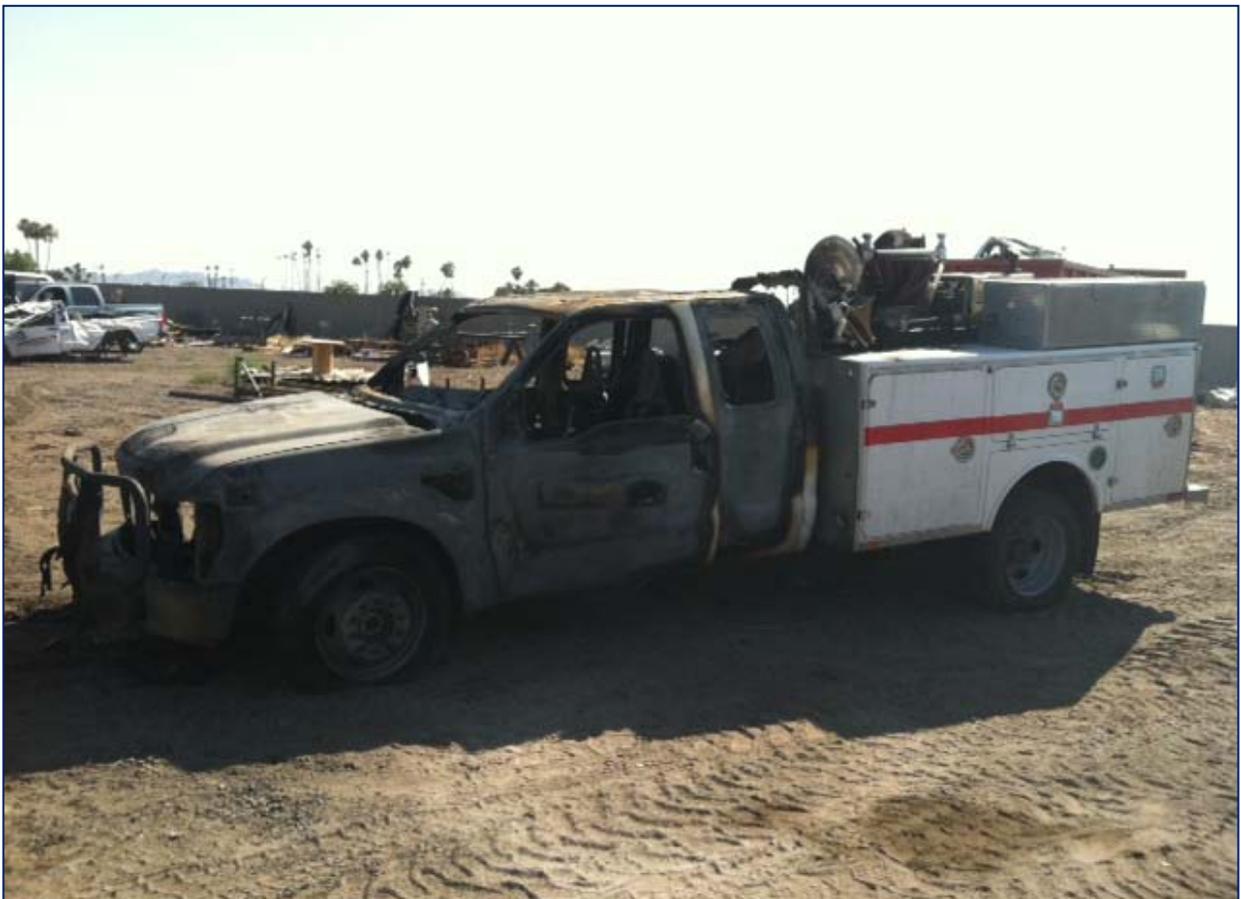
Redwood Engine 30 after the vehicle fire incident.

- All of cab—including wiring and electrical—was completely destroyed by fire.
- Front right tire was destroyed. All other tires remain intact (although the right rear outside dual was off the rim).
- Exhaust system—including Diesel Particulate Filter—remains intact with little damage.
- First section of the rear drive shaft is entirely split and spread wide open.
- Rubber components of the idler bearing on the rear drive shaft are melted.
- Components to the rear of the transfer case appear to have suffered far less fire damage than the front and right half of the vehicle.
- Four-wheel drive was not utilized while the vehicle was on assignment.

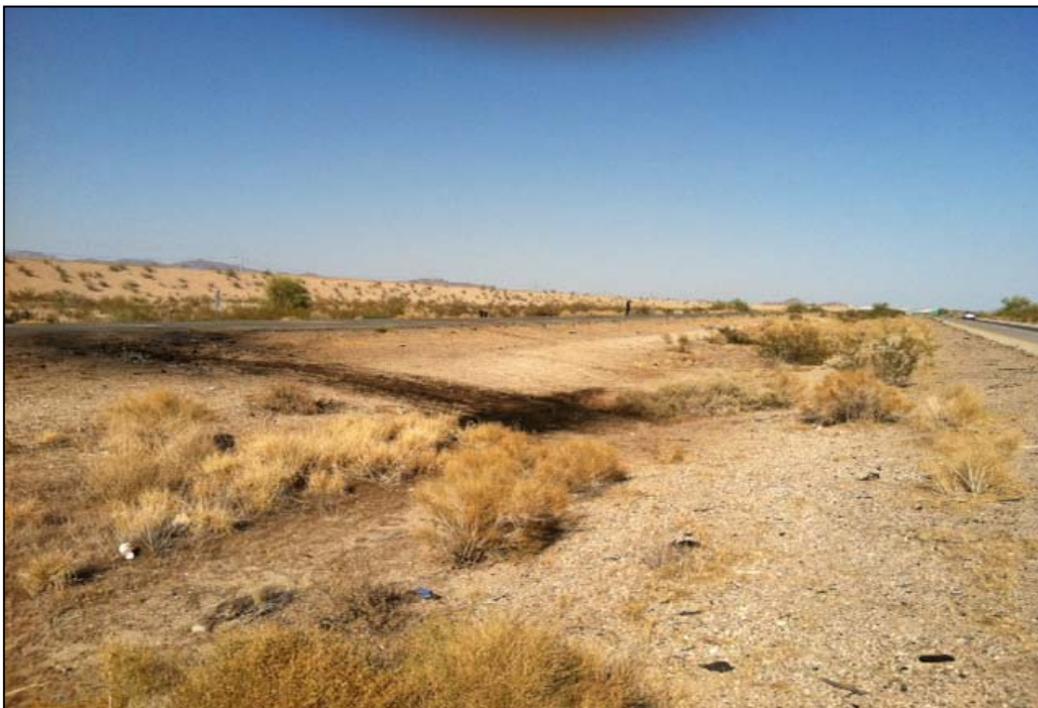
Burn Scorch Area
*– The Interstate 10
median space
where Redwood
Engine 30 burned.*

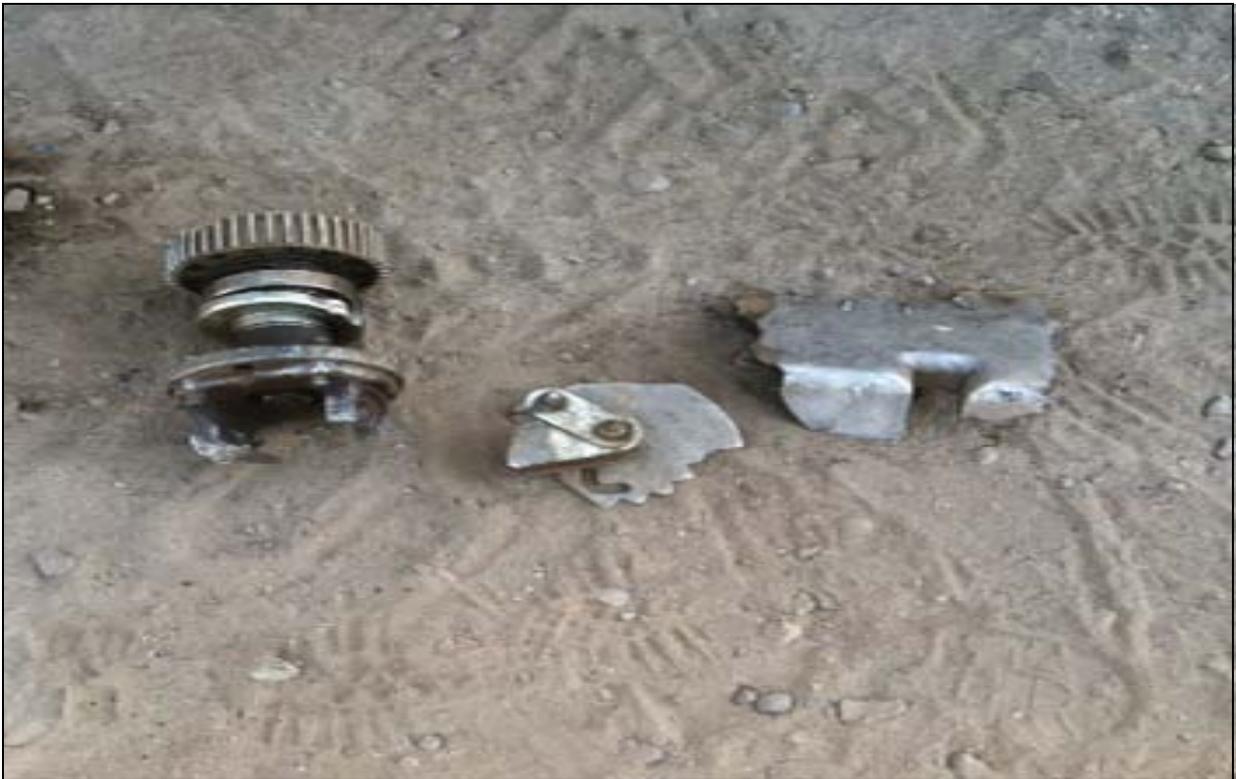
- After loud noise was heard, vehicle began to drive rough with mechanical parts falling to roadway from underneath vehicle.
- Drive train parts (specifically the transfer case) were found on roadway with no burn/charred marks.

- The transfer case was fully destroyed/disintegrated.

Drive train parts found on the roadway.

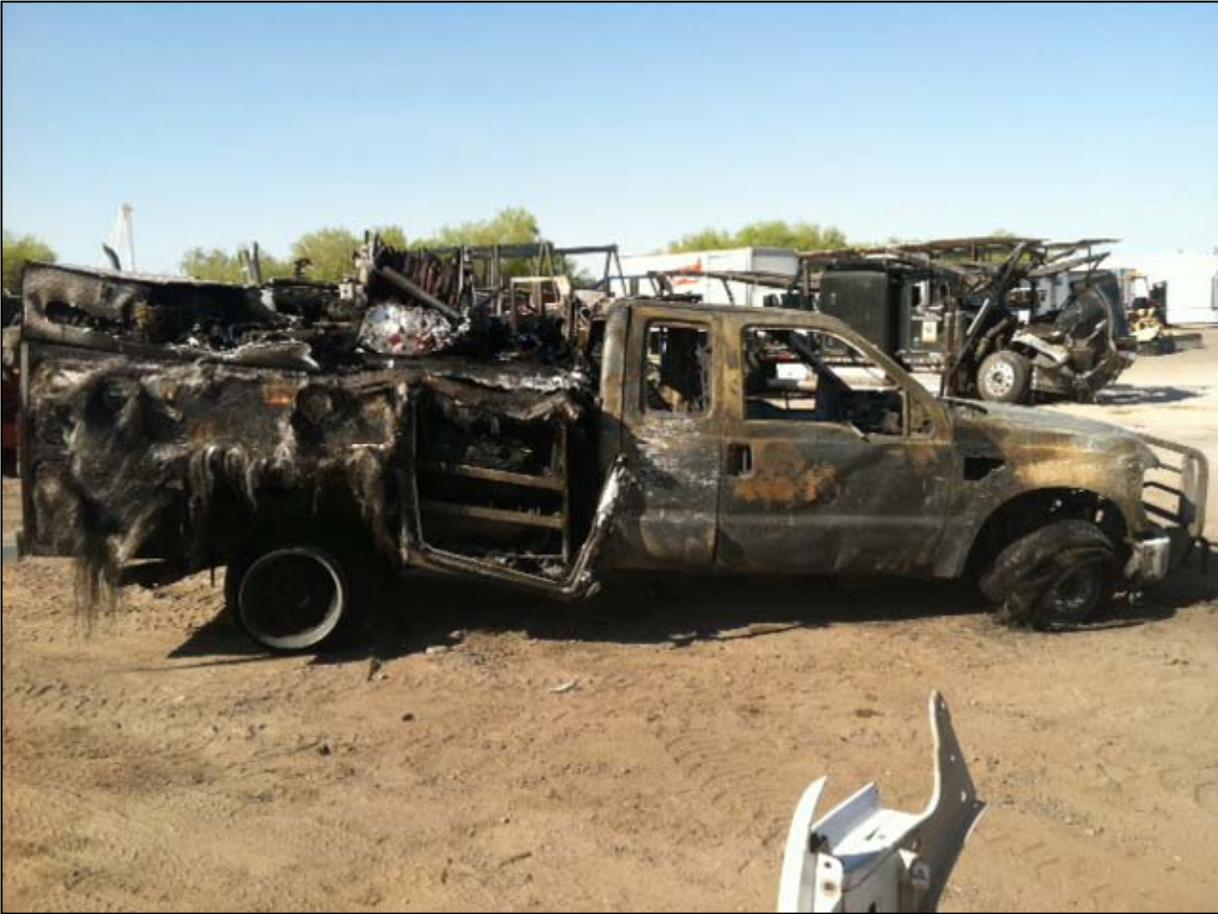
Redwood Engine 30 at the Arizona tow yard.

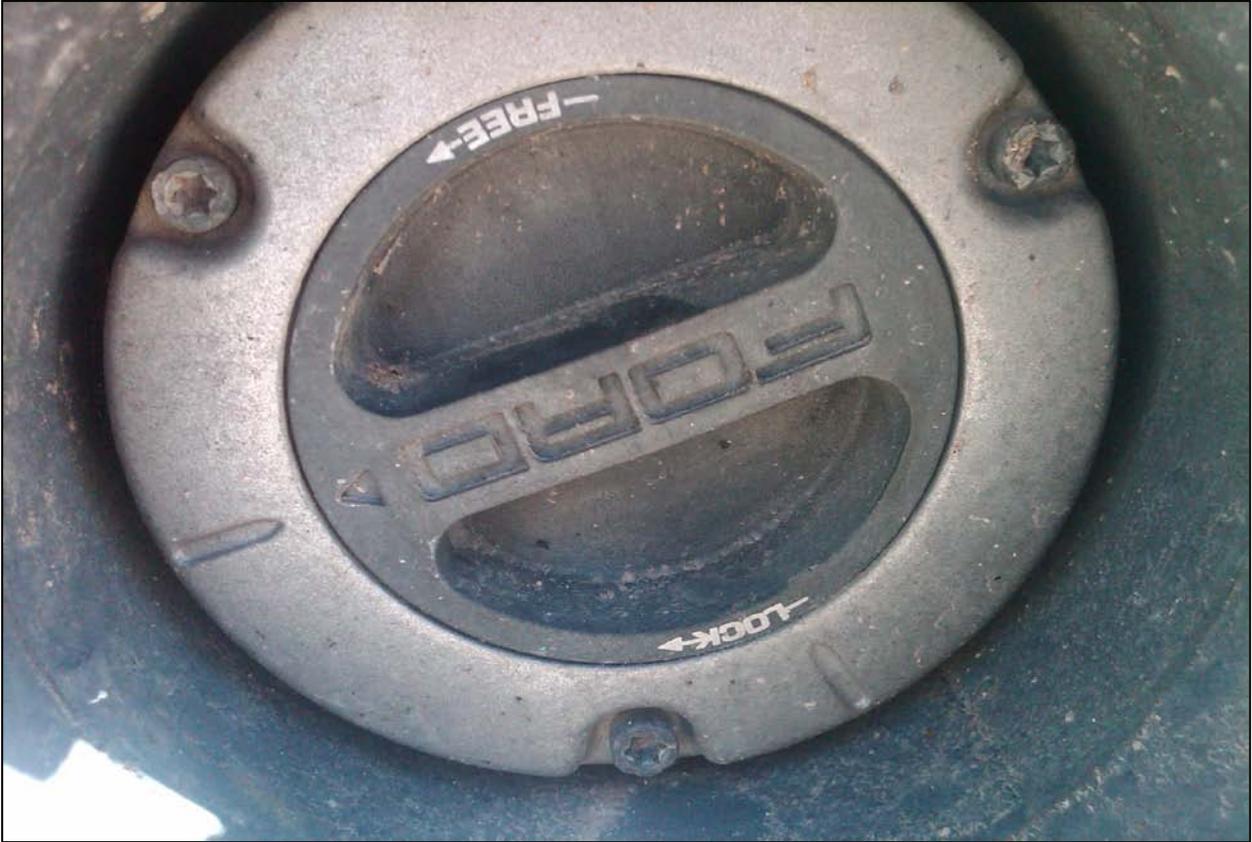
Locked Hub

- The left front hub was found in locked position.
- The right front hub was damaged in the fire. Therefore, its position could not be visually determined.

Four-wheel drive was not utilized over the course of the incident. However, the left front hub was found in the locked position.

Allowing the front axles and driveshaft to spin unnecessarily decreases fuel efficiency, causes unnecessary wear and tear, effects handling, and decreases performance. This causes unnecessary dangers and can lead to severe damage—and possibly fatal injuries. It is therefore important to follow the manufacturer’s recommendation and ensure that front hubs are not locked if four-wheel drive is not engaged.

1. Ensure daily preventative maintenance checks occur. Include checking manual or combination auto/manual locking hubs to ensure that they are in the proper position.
2. Ensure preventative and maintenance checks are performed regularly and documented.
3. Visually inspect and determine the transfer case and front hub engagement methods.
4. Operation of vehicle should be in accordance with the owner's manual.
5. An understanding of the various types of accident investigations/reviews, their purpose, and who is responsible would streamline information gathering and timeliness of distribution of lessons learned.
