Rapid Lesson Sharing

Event Type: Parked in Black Engine Fire

Date: August 18, 2017

Engine Parked in Cold Black Catches Fire

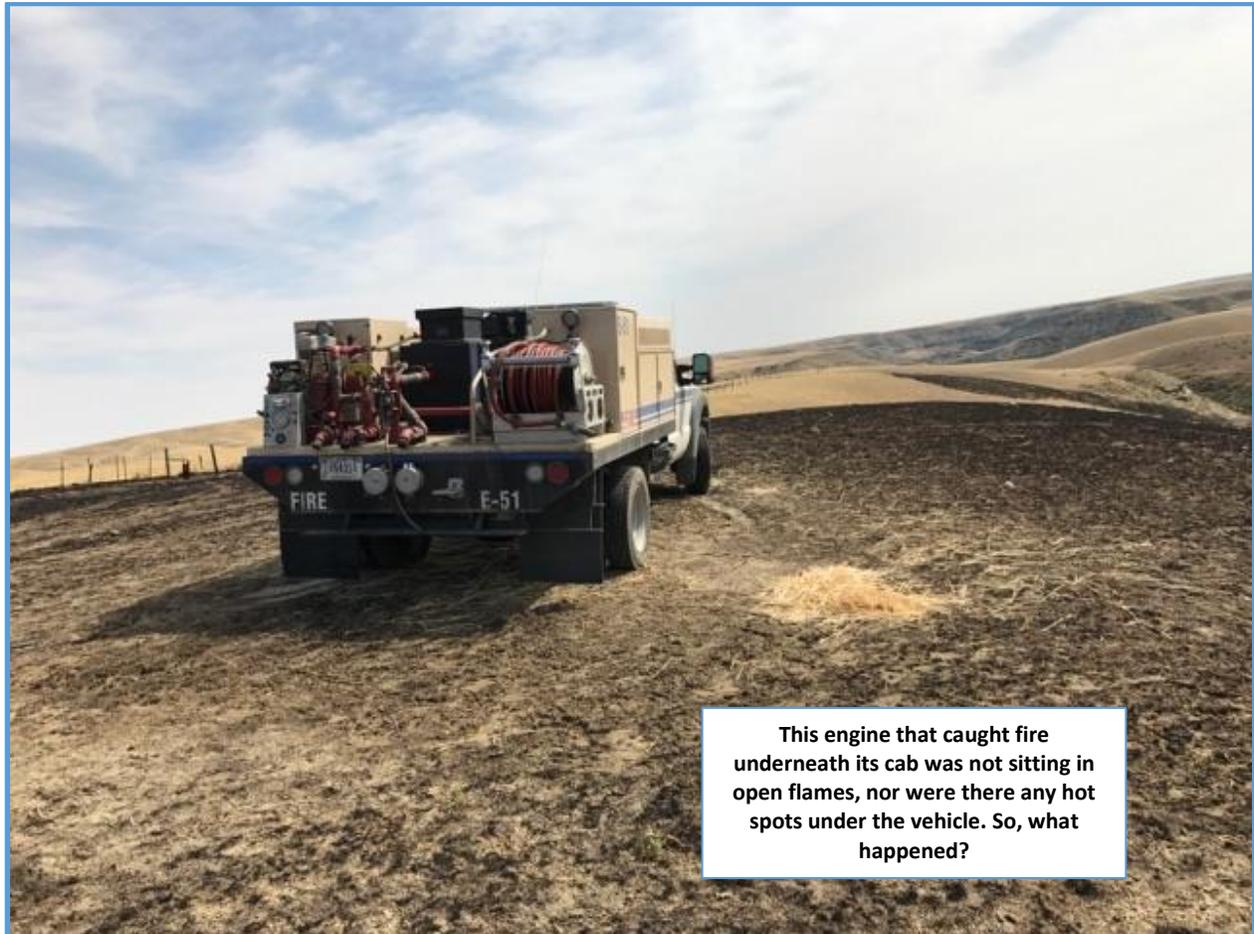
E-512 was sitting in cold black. When parked, there were no open flames or any hot spots under the vehicle. Suddenly, another engine noticed flames coming from underneath E-512's cab. The Engine Boss and the Crewmember jumped out of the vehicle and started spraying with hardline hose. "Instinct quickly kicked-in to put the fire out," the Engine Boss said.

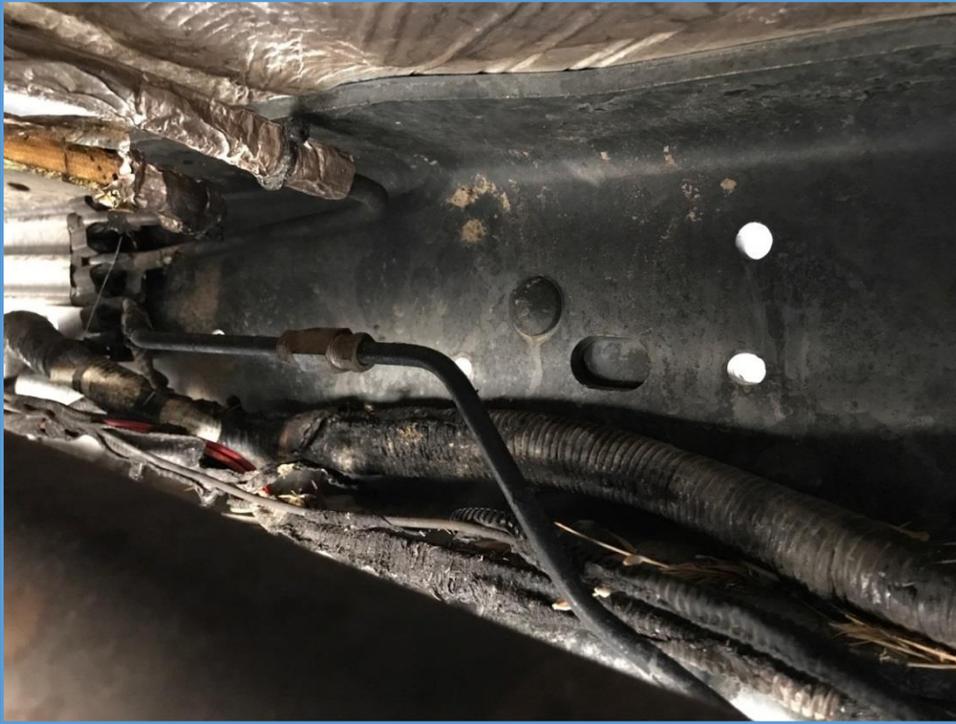
E-521 burn damage occurred to: the wiring harness located on the driver's side of the frame, the wiring above the transfer case, and two plastic/rubber fuel lines.

After a hands-on examination of this engine and the fire, it was determined that this incident was neither a mechanical error nor defect. No electrical lines had been cut or damaged.

Therefore, the buildup of fine fuels in the undercarriage that came from crossing wheat fields to access another incident prior to being dispatched to this initial attack incident in Cut Bank most likely provided the fuel for this fire.

The engine was towed from the fire to a local vehicle dealership where these damaged parts were replaced.
