Rapid Lesson Sharing

Event Type: Type 6 Engine Wheel Stud Malfunction and Torque Requirements

Date: September 26, 2017

Location: State Highway 78
Near Princeton, Oregon

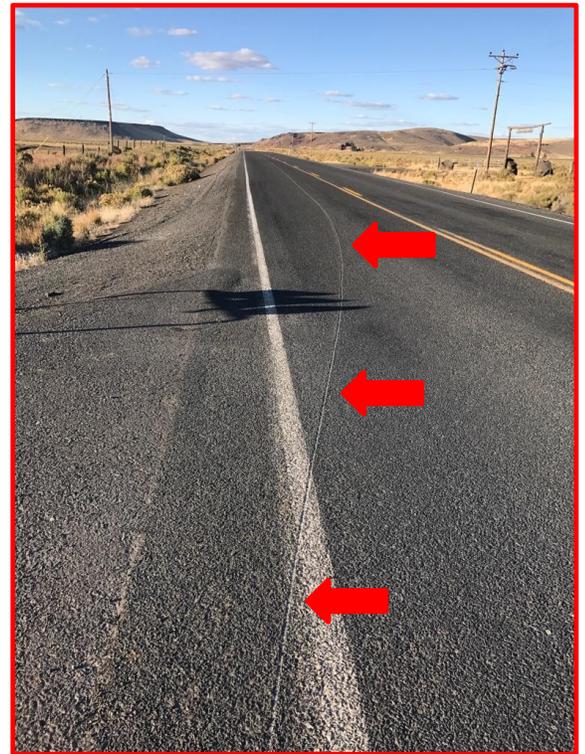
The indentation/mark left on highway by the rotor.

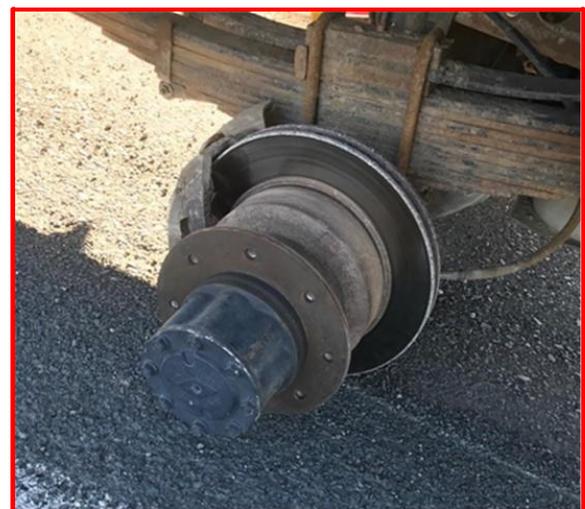
Condition of the hub and rotor when the engine came to rest.

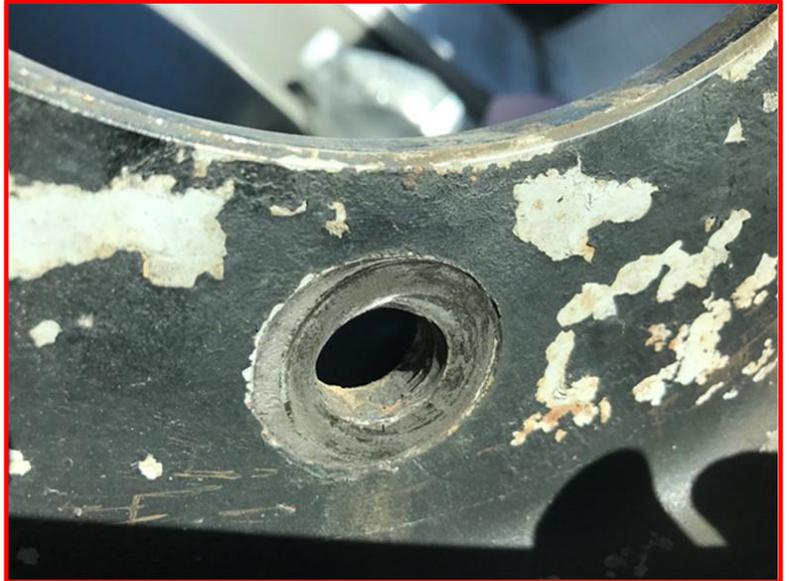
While reviewing the maintenance history of this engine and checking with the local tire center records, it was found that on June 14, 2017 the local tire center had replaced both tires on the driver side rear duals and the vehicle's spare tire. At the time of this event, the engine had slightly more than 2,000 miles of use on these tires.

The Fire Equipment Maintenance and Procedure Record (FEMPR) shows no tires replaced or re-torquing of replaced tires.

Photo shows lug nut wear on the wheel.

- ✓ Operators of vehicles who have had any reason to remove a tire from a vehicle, should follow re-torquing of the wheels as stated in the Owner's Manual. (See relevant Owner's Manual information on next page.)
- ✓ All types of service and repairs need to be documented in the FEMPR. This should include the re-torquing of the wheels.
- ✓ Spare District engines need to be better maintained and have all repairs and maintenance documented in the FEMPR for all Operators.

On vehicles equipped with dual rear wheels, retighten the wheel lug nuts to the specified torque at 160 km (100 miles), and again at 800 km (500 miles) of new vehicle operation and after any wheel disturbance (tire rotation, changing a flat tire, wheel removal, etc.).
