Beaver Fire Entrapment Facilitated Learning Analysis

**Incident Date:
August 11, 2014**

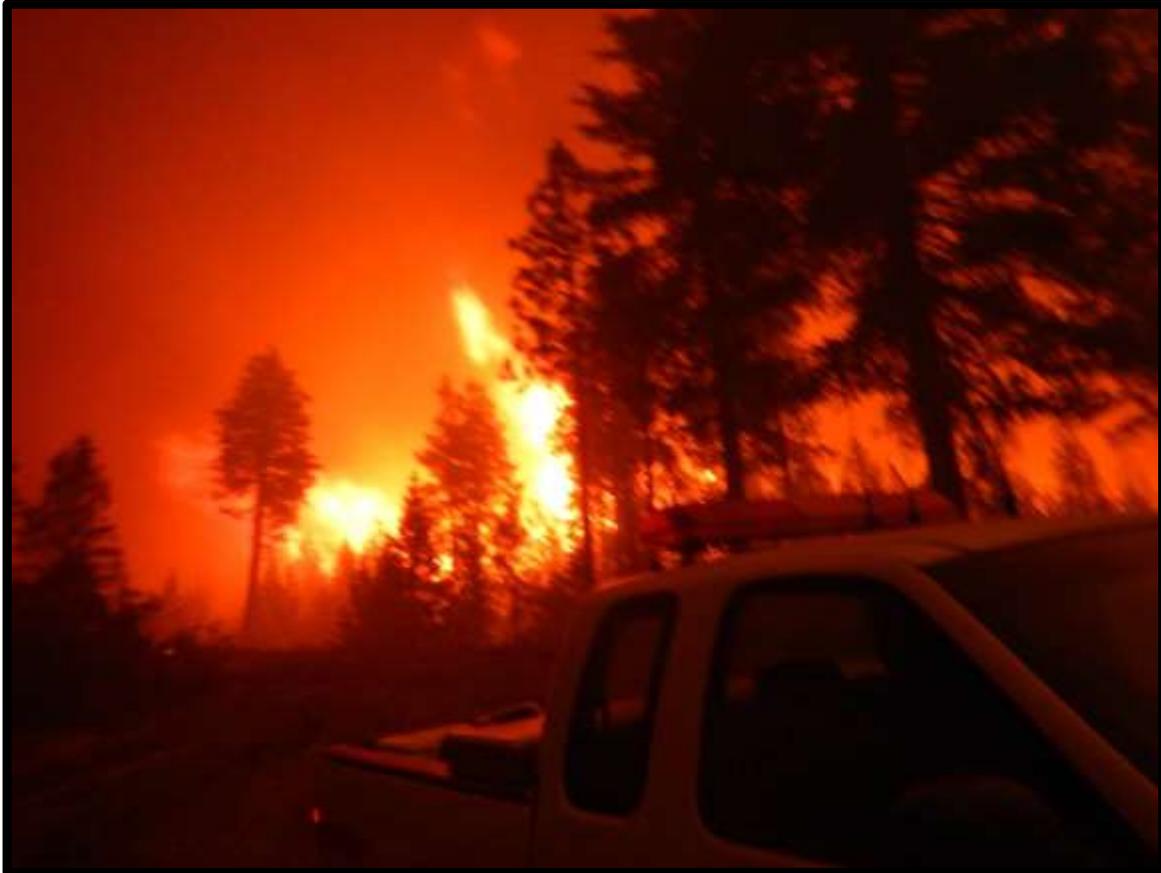
*The Division Supervisor's vehicle at the entrapment location
just prior to shelter deployment.*

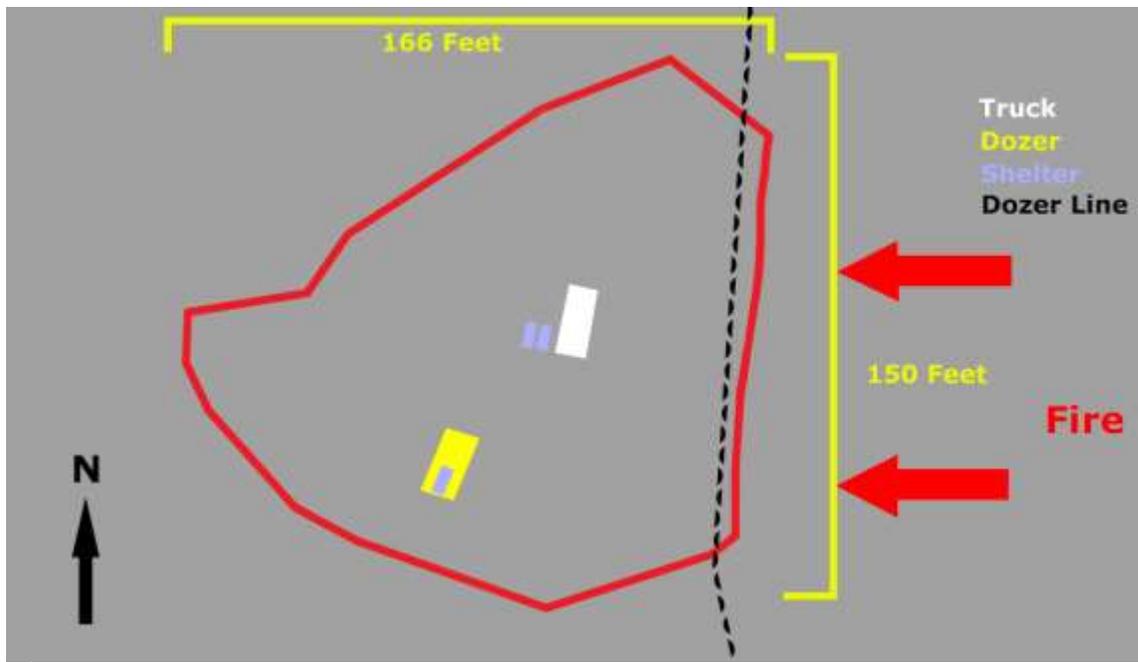
Entrapment Site Map

The dozer-cleared area measures 0.4 acres. DIVS C and HEQB (t) deployed their shelters beside the truck while DZOP deployed his shelter beneath the rear of the dozer.

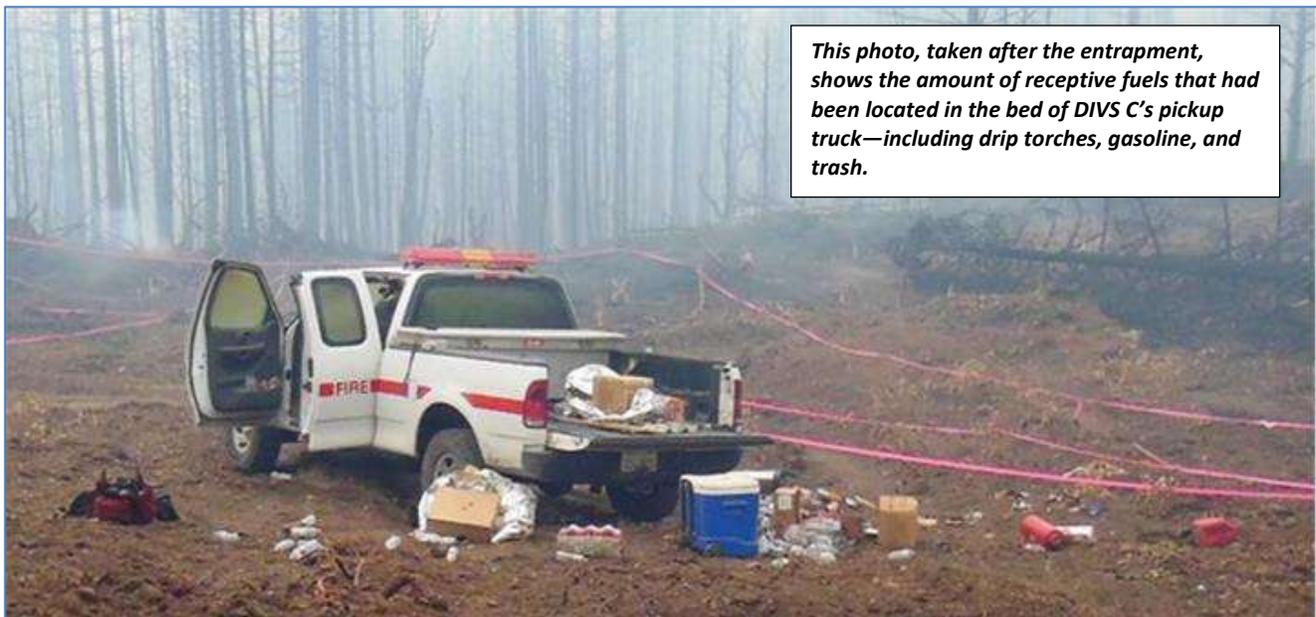
This photo, taken after the entrapment, shows the amount of receptive fuels that had been located in the bed of DIVS C’s pickup truck—including drip torches, gasoline, and trash.

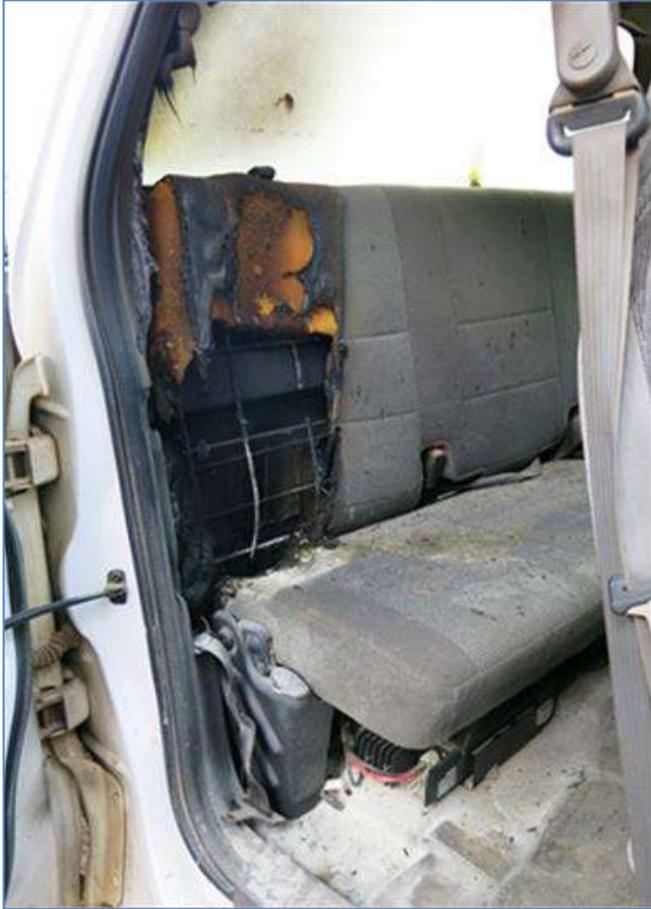
Photos show the fire damage—including melted plastic—that occurred to DIVS C's pickup truck when the contents in the truck bed ignited.

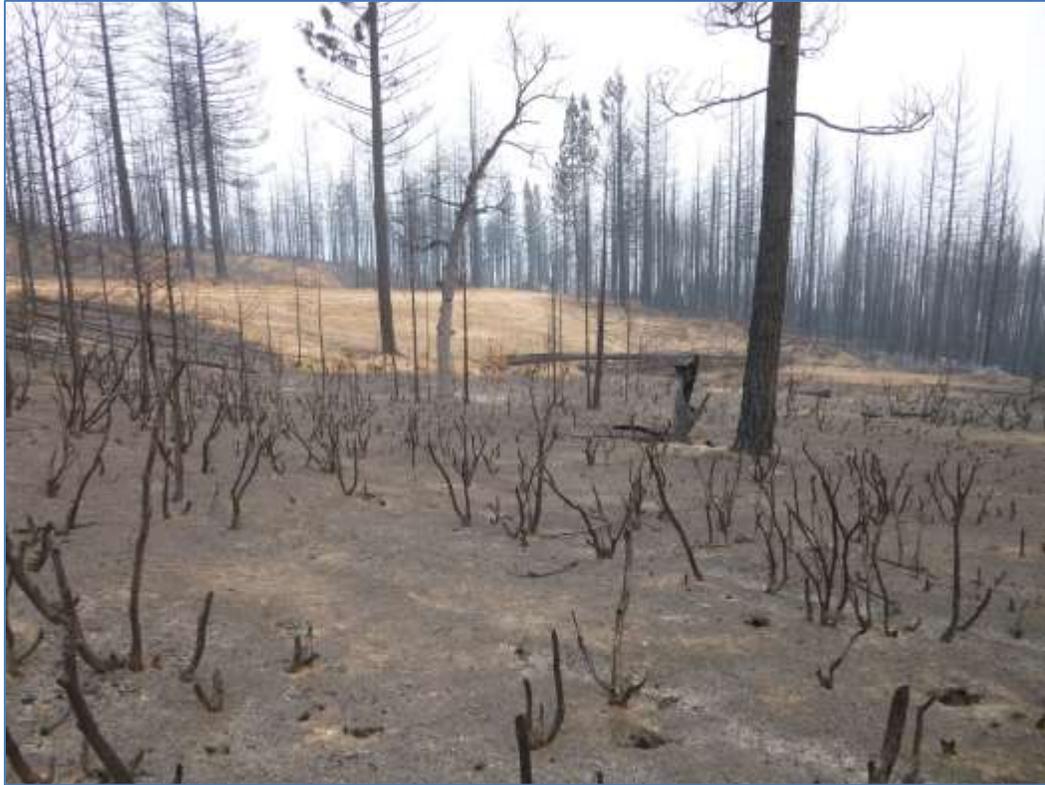
Top Photo – Shelter deployment site looking southeast.

Due to the long-term drought and the lack of seasonal rains, the fire completely consumed virtually all fuel classes (see photos on next page).

Photos show the severity of the burn where the Beaver Fire burned through the entrapment location.

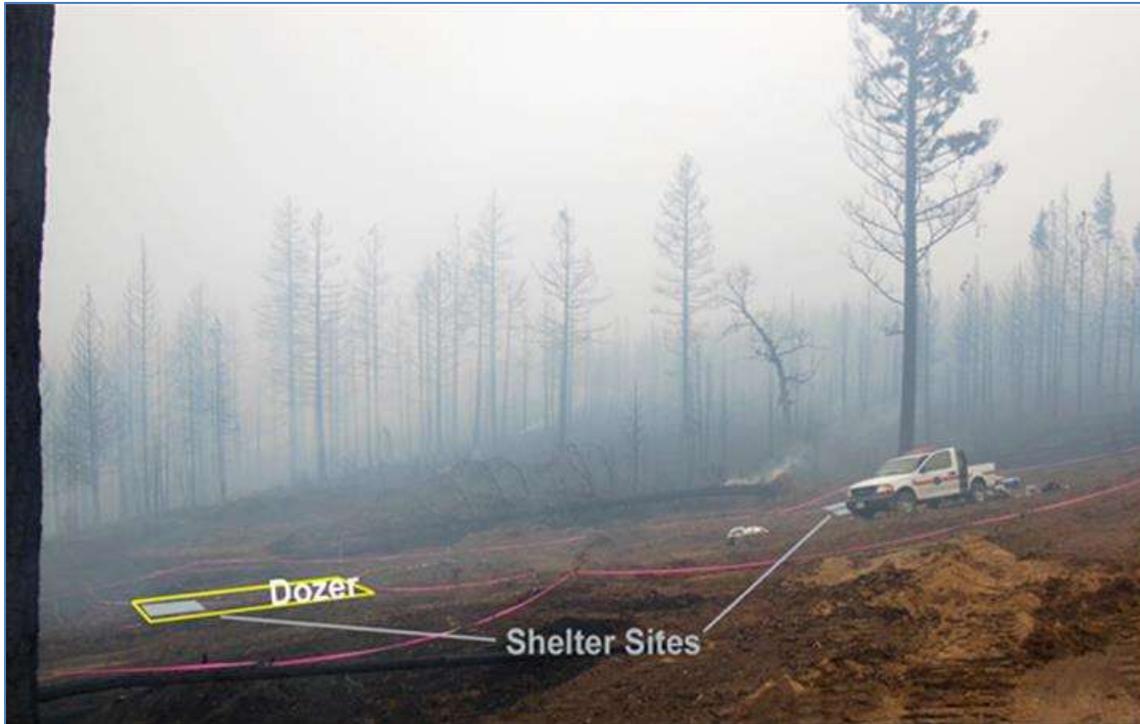
Photo shows shelter sites—the DZOP deploying beneath the rear of the dozer and DIVS C and HEQB (t) deploying beside the truck.

Fire shelter training states to deploy shelters in the biggest clearing possible—away from large, potential fuels. Once a vehicle starts to burn, it becomes a fuel source. Therefore, if you deploy a shelter near a vehicle, you may be exposed to additional risk by needing to move while inside your shelter.

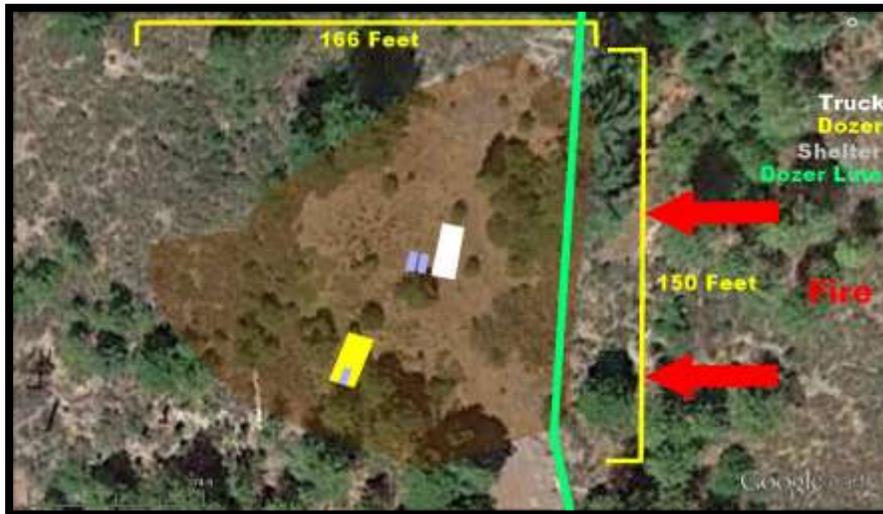
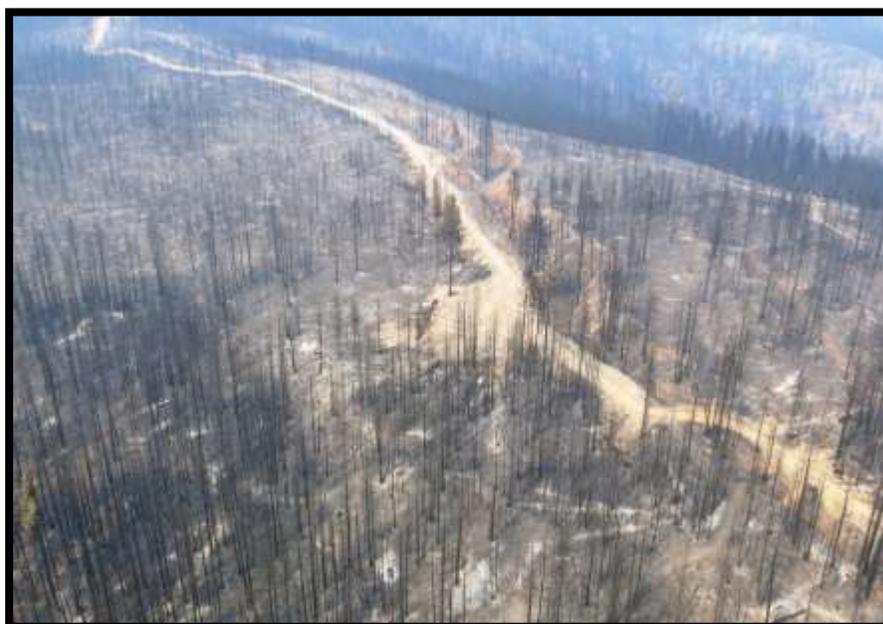
Entrapment/Shelter Deployment Site

- **Latitude:** N 41° 51.027, Longitude: W 122° 58.105
- **Elevation:** 3257 feet.
- **Size:** 0.4 acres
- **Description:** The entrapment site was a small clearing in the timber. The dozer spent approximately 25 minutes improving the site in an attempt to make it a safety zone. The fire arrived before that goal was accomplished. The dozer pushed over approximately 20 trees on the south side of the site and cleared small manzanita brush throughout. The dozer work provided a sufficient deployment site that offered protection from direct flame contact. However, a high level of radiant heat was present during the burnover. All equipment and flagging that marked the locations of the equipment and personnel were removed before the FLA Team's arrival. Measurements of the locations of equipment were taken by IMT personnel.

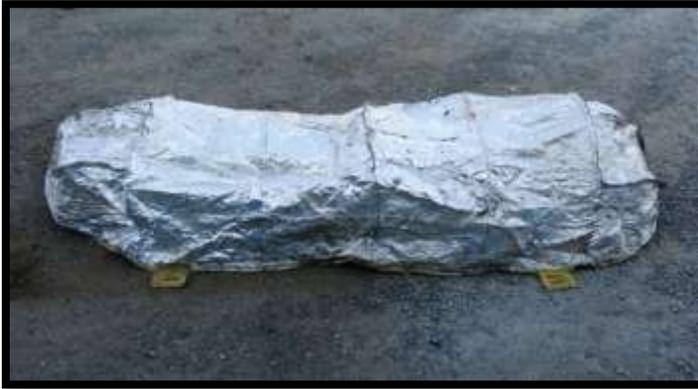
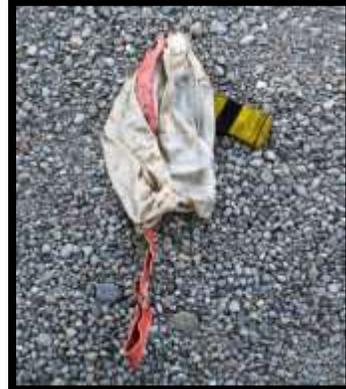
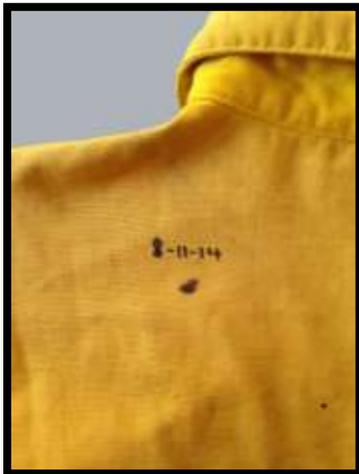
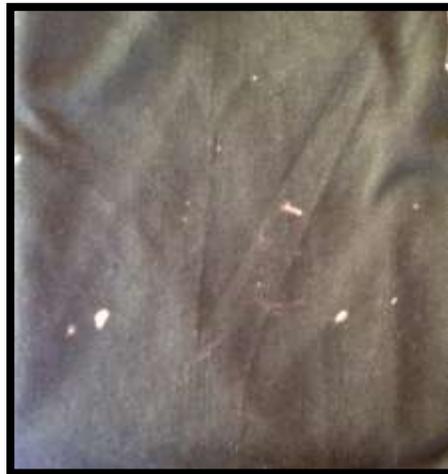
DIVS C

- **Fire Shelter:** Manufacture Date – January 2005. No signs of extreme heat. Due to a brief rain shower after the entrapment, the shelter was wet when inspected.
 - Structural Condition: 1-inch tear of the inside corner of the floor opening. Along fold lines there were a few small cracks in aluminum foil of outer shell.
- **PVC Bag:** The bag was partially melted during the entrapment. The bag and red tear strip appear to have performed as designed.
- **Clothing:** The FR clothing had numerous spots of dye sublimation and char from hot embers— 8 spots on shirt and 103 on pants.

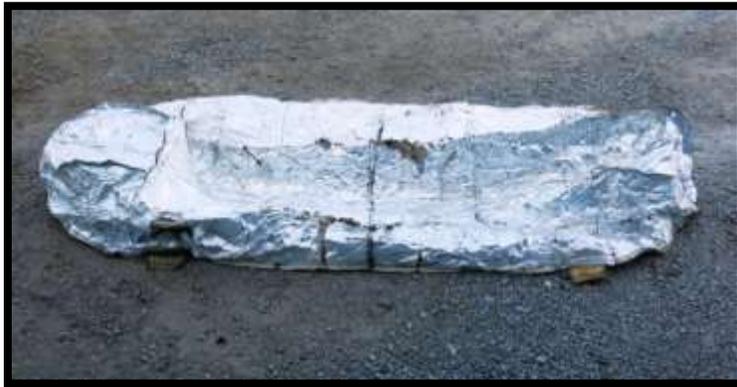
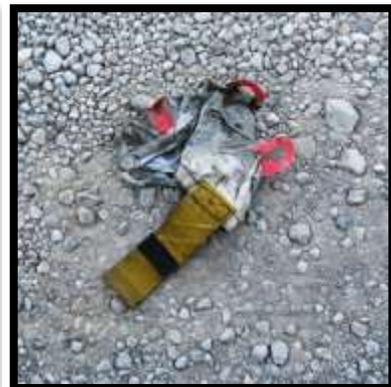
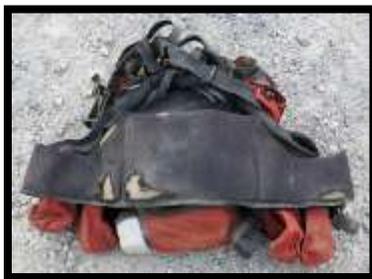
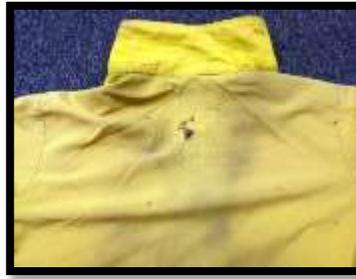
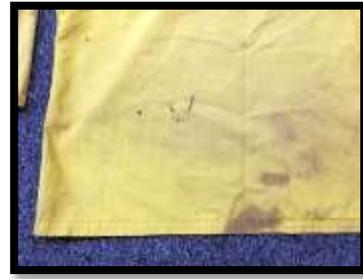
Indications are that the PVC bag of the “new generation” shelter used by the HEQB (t) was dark grey and black in color—due to wear-and-tear prior to this incident. The shelter was therefore worn on the fold lines. It appears that the shelter was well beyond its service life.

- **Fire Shelter:** Manufacture Date – July 2003. The shelter was recalled and retrofitted in 2004. No signs of extreme heat. Due to a brief rain shower after the entrapment, the shelter was wet when inspected.
 - Structural Condition: Aluminum foil was worn away on many of the fold lines of the outer shell. Delamination of the foil to the outer shell, inner shell, and floor materials was present. The water from the rain shower may have increased the amount of delamination.

- **PVC Bag:** Dark gray aluminum foil residue was present inside the bag, indicating excessive wear prior to the deployment. The bag was partially melted during the entrapment.
- **Hard Plastic Liner:** The exposed edges of the liner were melted and deformed.
- **Clothing:** FR Shirt had spots of dye sublimation and char, most likely caused by hot ember contact during the entrapment.
- **Fireline Pack:** Numerous melt spots were present on the pack, most likely caused by hot ember contact during the entrapment.

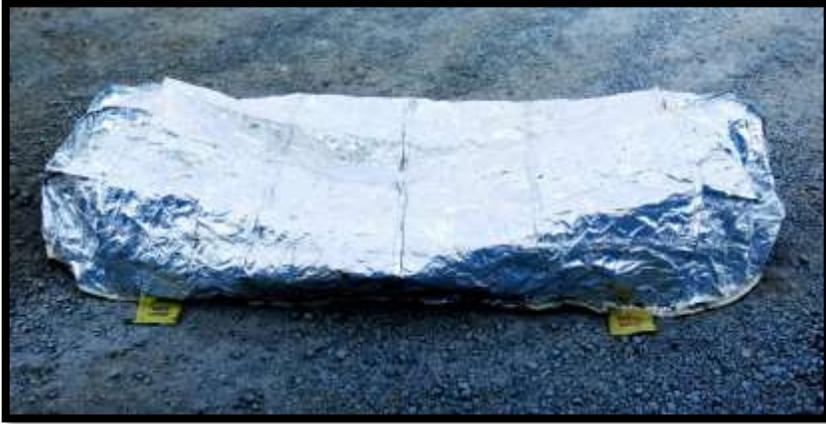
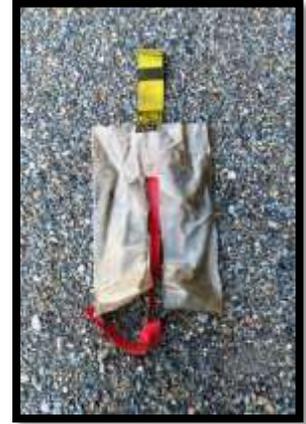
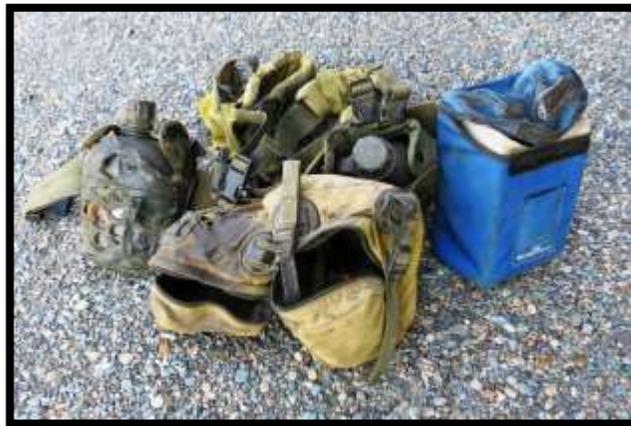
DZOP

- **Fire Shelter:** Manufacture Date – January 2005. No signs of extreme heat. Due to a brief rain shower after the entrapment, the shelter was wet when it was inspected.
 - Structural Condition: OK
- **PVC Bag:** The yellow nylon webbing pull-strap was detached during the extraction of the shelter. The pull-strap had no reinforcement. The firefighter reported that the red tear strip did not initially open the bag when he pulled it, but he was able to tear the bag open along the red tear strip. The bag had several melted spots.

- **Fireline Pack:** General melting of the exposed nylon cloth was present.
- **Hard Plastic Liner:** The exposed edges of the liner were melted and deformed.

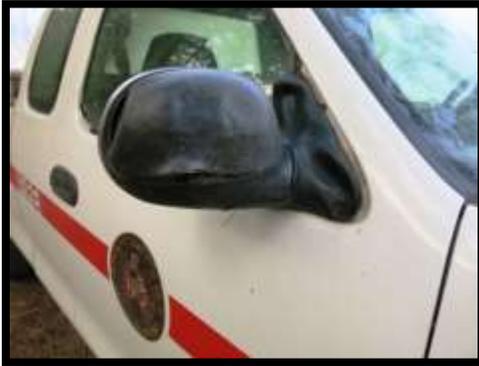
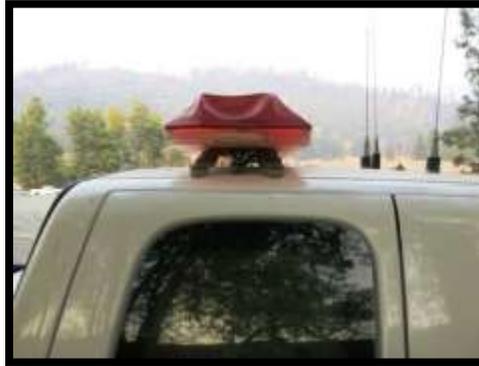
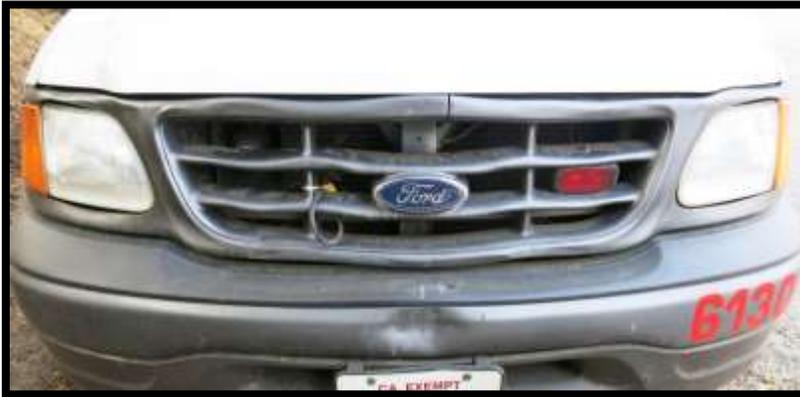
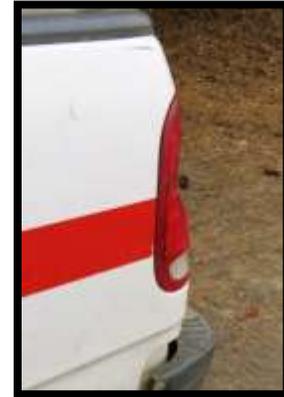
Truck

- The DIVS C truck was damaged due to the contents in the bed igniting as well as by radiant heat from the vegetation fire during the entrapment. The rear view mirror assemblies, front grill, light bar, and tail lights were melted and deformed.
