In-Flight Action Award David Fennen

Reference: SAFECOM 19-0351

Tracking #: 19-0351

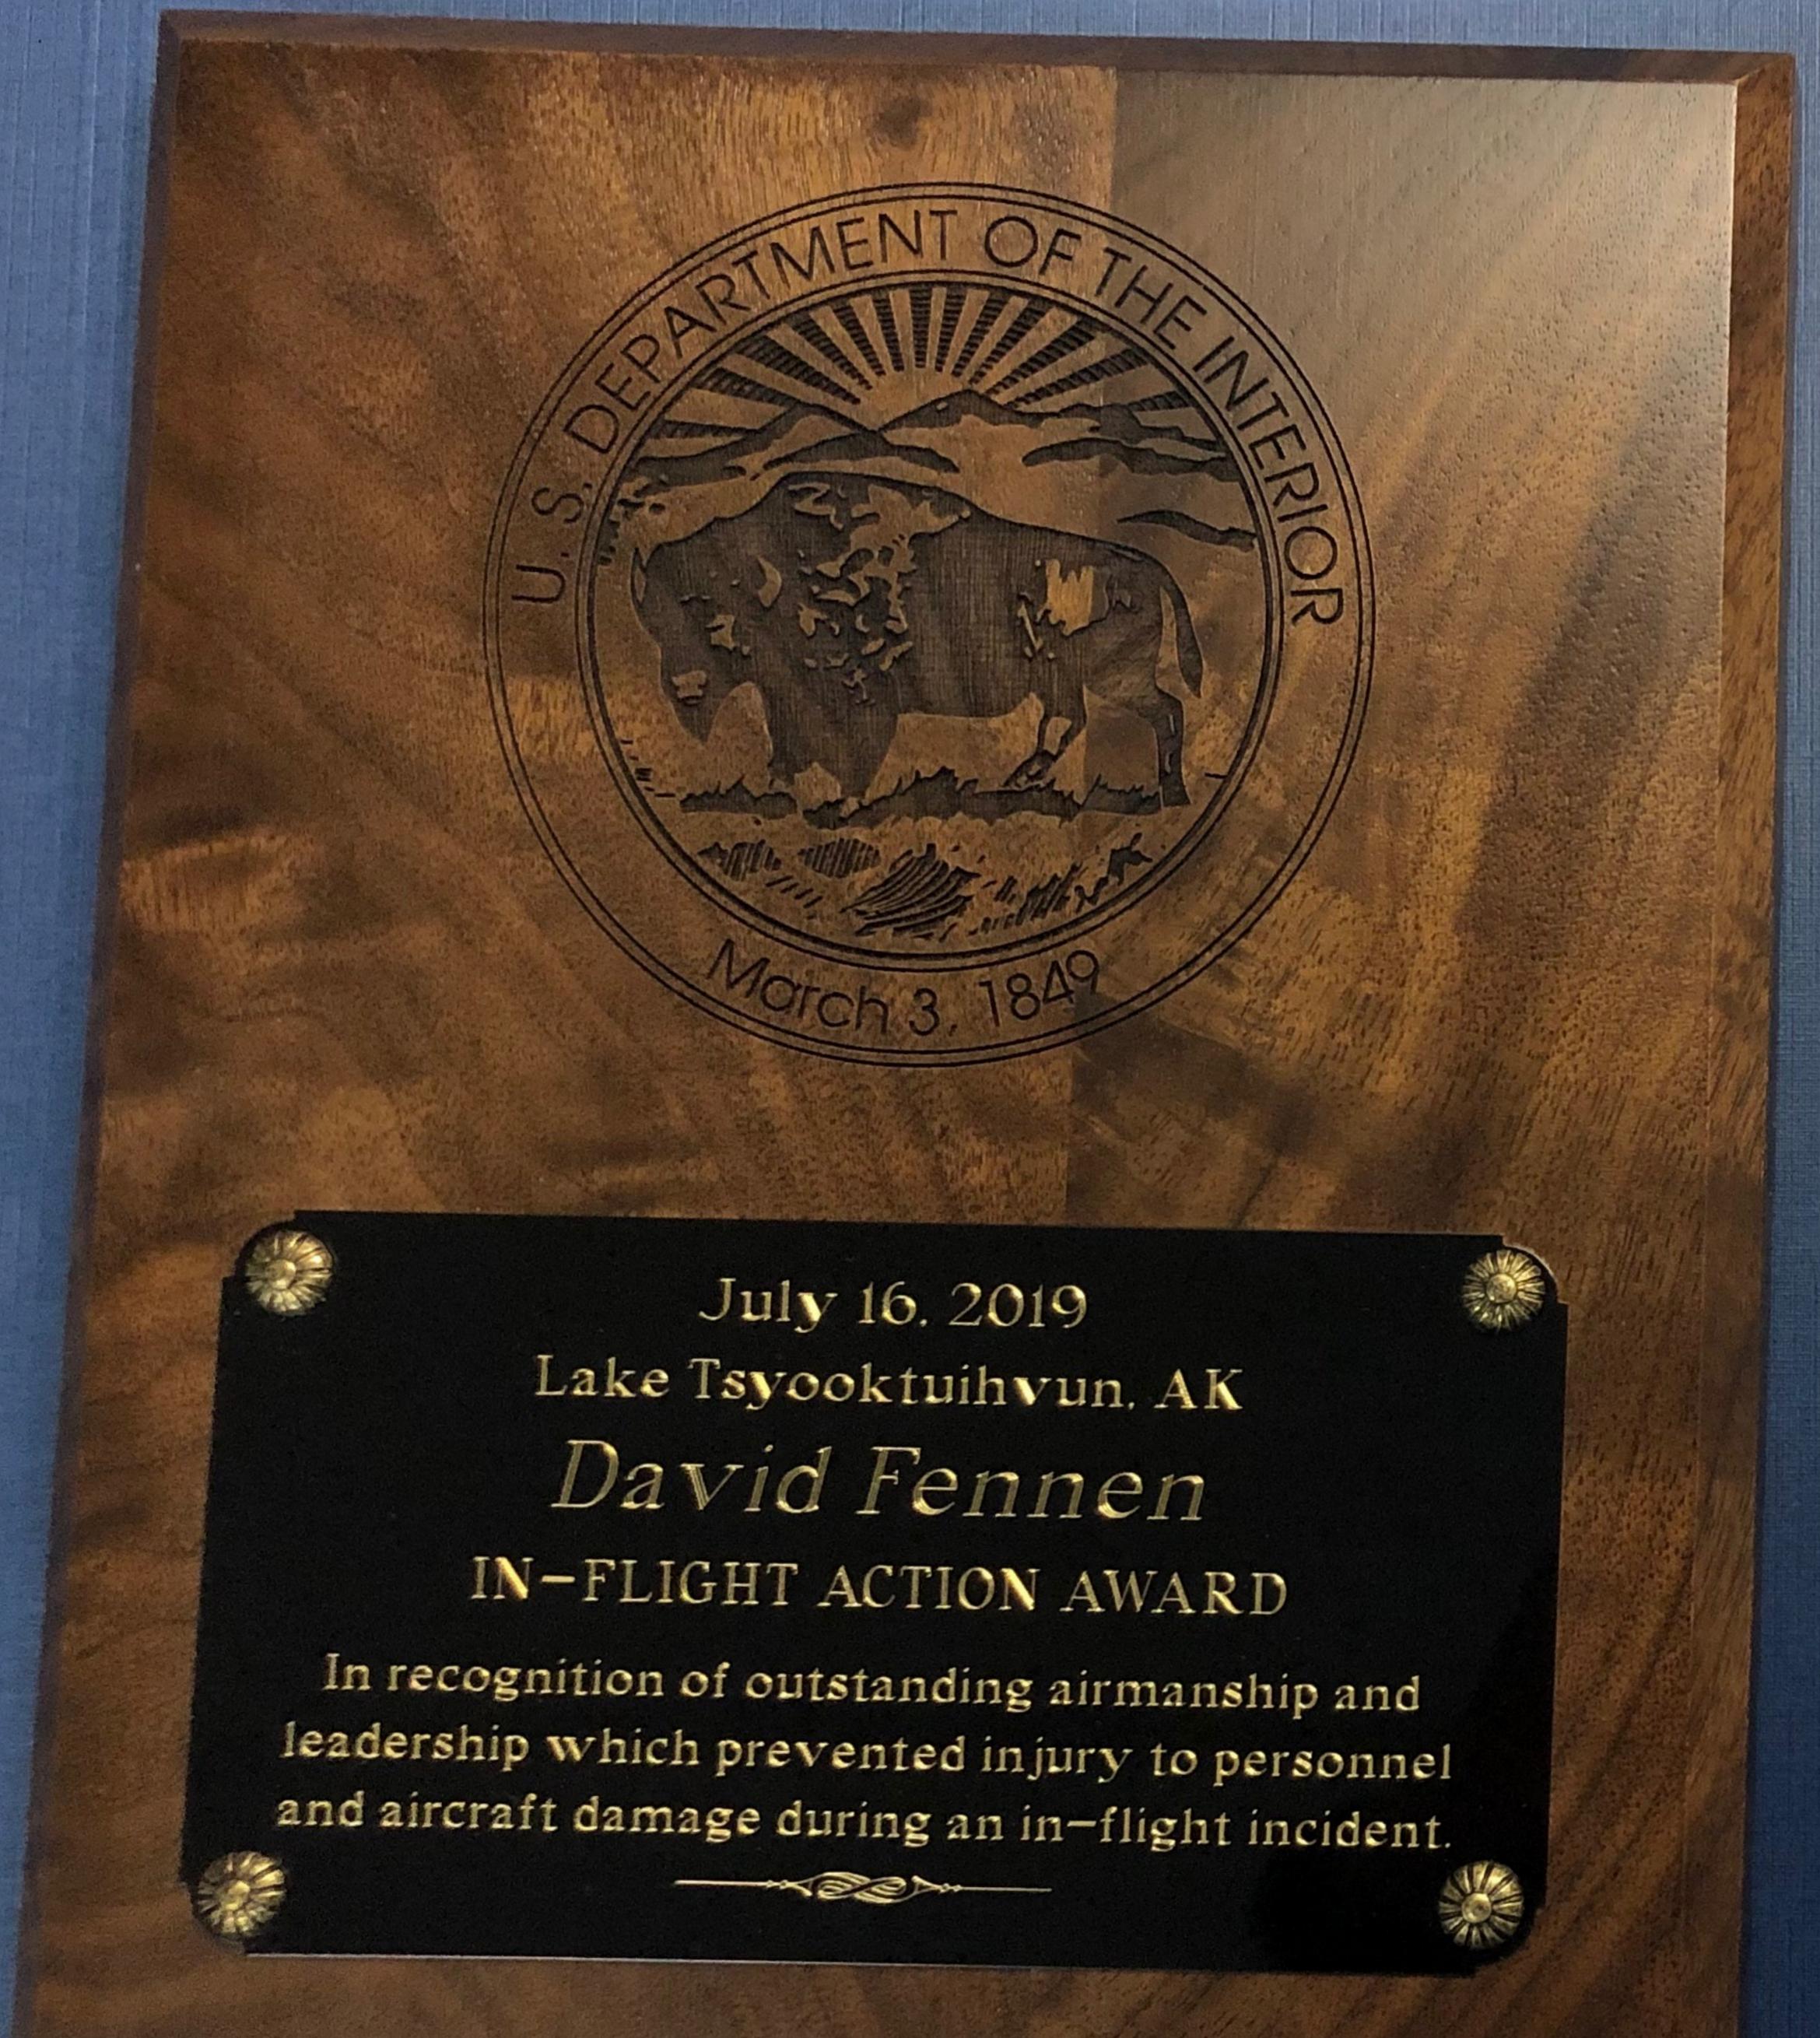
On July 16, 2019, an in-flight incident occurred while working on the Lake Tsyooktuihvun fire. During the fourth scoop, the aircraft's fill scoops failed to retract causing the tank to fill to max capacity and subsequently overflowing out of the top, which reduced forward visibility out the windscreen to zero. Dave immediately activated the emergency dump system and jettisoned the load. As later determined during post-flight maintenance inspections, the scoops could not retract due to a mechanical issue. Therefore, during the scoop abort, the scoops continued to fill and visibility was not regained as would normally occur once they had retracted. Dave then selected max power and successfully accomplished a water takeoff. Once he was off the water surface and airborne again, visibility greatly improved. He then aborted the mission and returned to Fairbanks, without incident, for maintenance.

During the fourth scoop the Fire Boss scoops failed to retract causing the tank to fill to max capacity subsequently blowing out the top which reduced forward visibility out the windscreen to zero. The PIC immediately activated the emergency dump system and jettisoned the load. As later determined during post-flight maintenance inspections, the scoops could not retract due to a mechanical issue. Therefore, during the scoop abort, visibility was not regained as would normally occur immediately after jettisoning the load once the scoops retracted. The PIC then selected max power and successfully accomplished a water takeoff. The PIC then aborted the mission and returned to Fairbanks for maintenance. BLM AV Safety, WS, 7/23: Scoops remained down after jettison of load and continued to fill causing visibility issues, after the water takeoff visibility improved out the windscreen. Excellent situational awareness by the pilot.

Inspect scoops to determine cause of scoop retraction failure. BLM AV Safety, WS,7/23: The mechanical issue turned out to be a faulty hydraulic Vickers valve which was replaced by the mechanic. Operations checks were positive and OAS inspector returned the aircraft to contract availability on 7/18.
