Executive Summary

On Sunday, September 14, 2014, a Bell 206L-1 (NXX) contractor owned and operated aircraft was involved in a mishap while conducting a fire suppression operation approximately 50 nautical miles south of Burns, Oregon. The fire suppression mission was in response to a scheduled prescribed burn for the Moon Hill RX that exceeded the set boundary (although within the designated project area). The mission was under the operational control of the BLM.

Bureau of Land Management, Incident-With-Potential, NXX
Burns, OR.

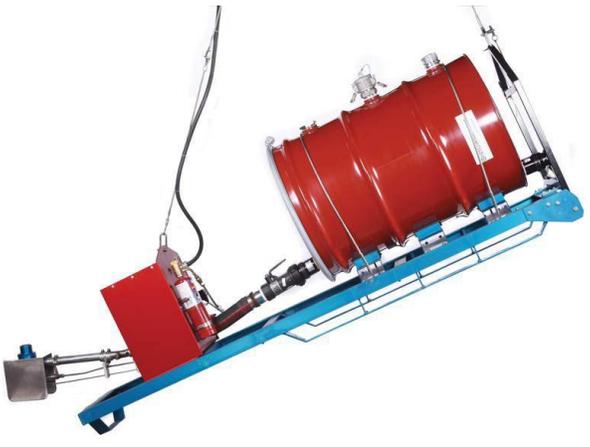
Figure 1. Generic picture of a helitorch

The mishap aircraft, NXX a 1978 Bell 206L1 C30P, was initially configured with a helitorch used for aerial ignition of ground fuels (Figure 1 and 2).

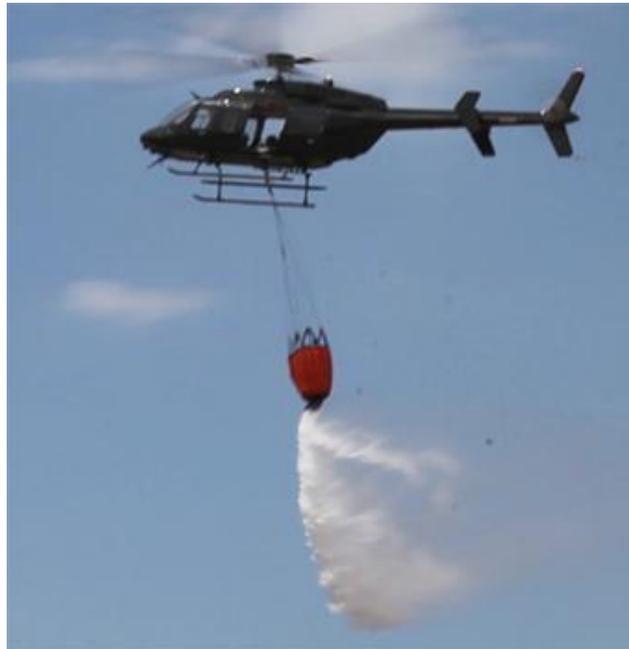
Figure 3. Representative photo of a Bambi bucket.

The Bambi bucket, model 9011,² was cinched to 80% which allowed 86 gallons of water to be drawn and delivered. A 100 foot, 5/16" steel cable attached the bucket to the aircraft.

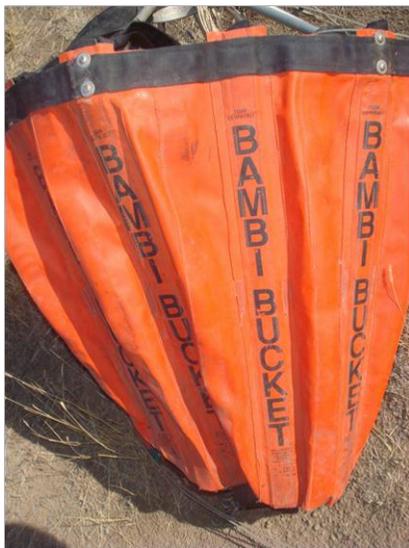
Figure 9. Bambi bucket

NXX was a 1978 Bell 206L1 C30P⁵ configured with a 5/16 inch, 100 foot steel cable. At the end of the cable was a model BB9011 Bambi bucket (Figure 9 and 10, page 13). The BB9011 holds 108 gallons of water⁶ and weighs 85 pounds empty with a gross weight of 970 pounds. The Bambi Bucket in use was cinched to 80%, meaning that the bucket could only take and release 86 gallons or 717 pounds of water⁷. The long line was attached to the cargo hook on the helicopter.
