Balance Rock Accident Investigation Team

Accident Investigation Factual Report Balance Rock Rollover Engine E2421

Bureau of Land Management
Twin Falls District, Idaho

August 21, 2006

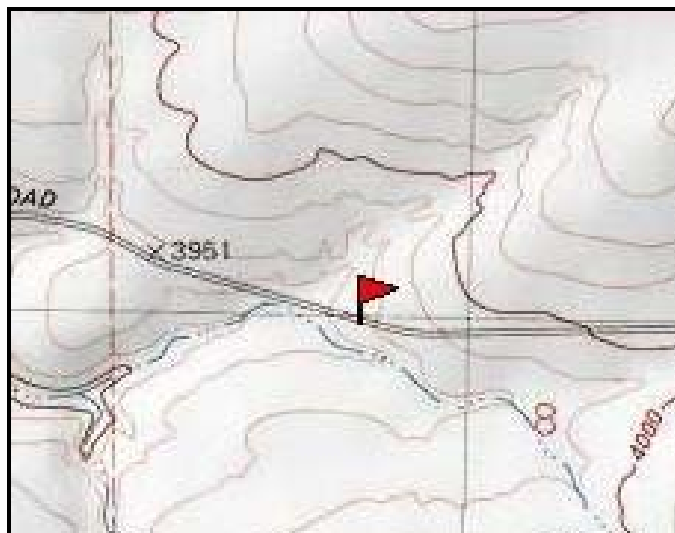
Balanced Rock Rollover Site Map

The accident occurred on Balance Rock/Crows Nest Road, approximately 11 miles West of Castleford. This is a BLM owned gravel road, which is maintained by cooperative agreement by Owyhee County, Idaho (see Attachment F).

For the area of the road where the accident occurred, the road conditions are characterized as moderately rough, with a slight decline and “wash board” type bumps and ruts. Two and three foot diameter rocks are present on both sides of the road.
