Rapid Lesson Sharing

Event Type: Type 6 Engine Wheel Stud Malfunction and Torque Requirements

Date: September 26, 2017

Location: State Highway 78
Near Princeton, Oregon

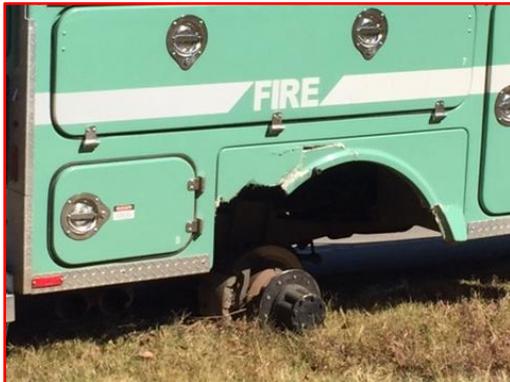
Type 6 Engine Wheel Torque Malfunction RLS

While driving their engine down Interstate 40, the Operator suddenly feels a change in driving characteristics as one of their passenger-side rear duals suddenly passes them!

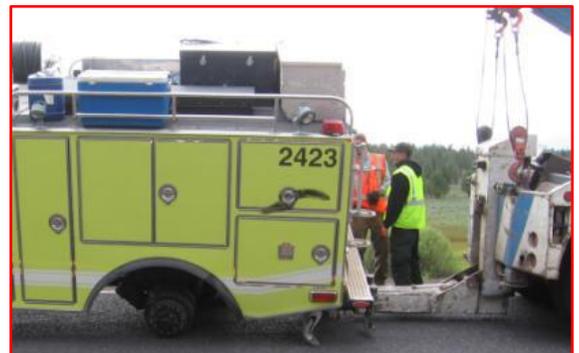
Engine 2423 Lessons Learned Review

The purpose of this paper is to document the sequence of events that occurred before and after the incident involving this engine and identify learning points for future operations.
