Beaver Fire Entrapment Facilitated Learning Analysis

**Incident Date:
August 11, 2014**

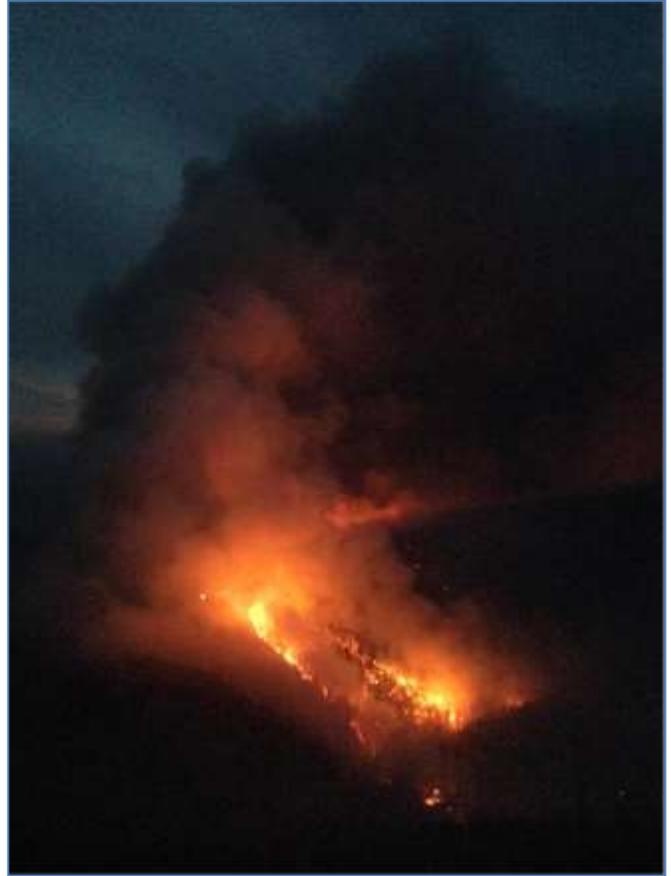
The Beaver Fire on August 10.

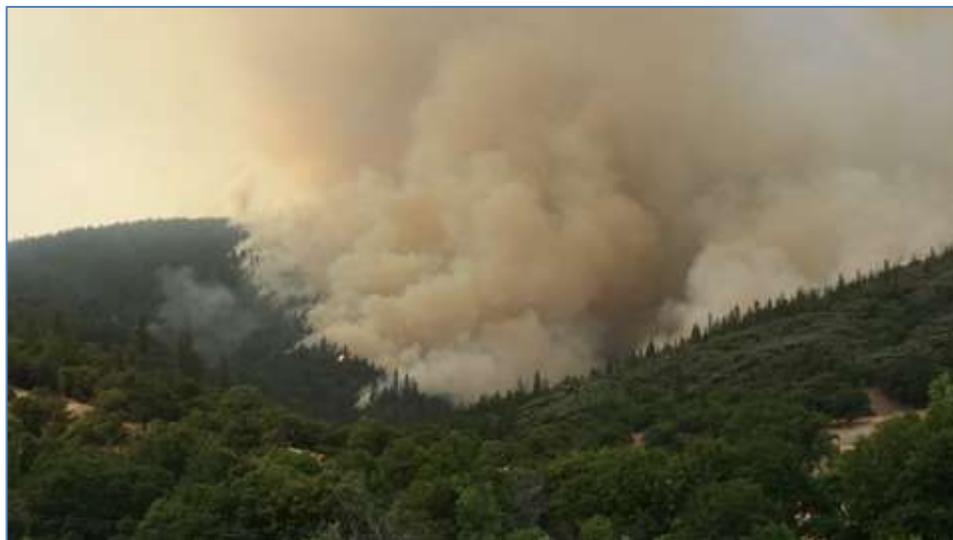
Throughout the afternoon of August 11, fire activity was escalating on the Beaver Fire.

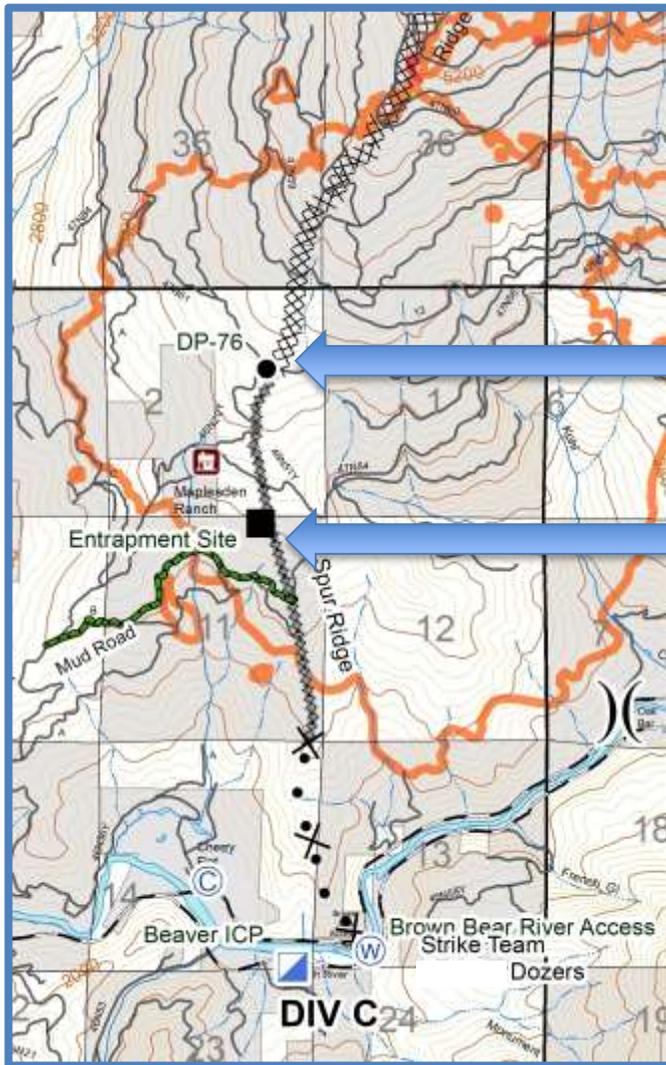
**With Fire Moving Toward Them,
Decision Made to Exit Drop Point 76**

Top arrow points to Drop Point 76, where—with the fire quickly approaching their position—DIVS C, Operations Branch Director (OPBD), DIVS V, and a Strike Team Leader from DIVS V met to evaluate their rapidly escalating situation. They decided they needed to make a quick exit in their vehicles via the existing road system. DIVS C opted to drive south on the incomplete piloted dozer line to check on HEQB (t) and DZOP.

However, due to several old cars and farm equipment located on private property next to the piloted, incomplete dozer line—in addition to the sudden, rapidly approaching fire front—this escape route was not a realistic option.

Therefore, HEQB (t) made a plan to construct the incomplete safety zone as large as possible and confront the fire where they were.

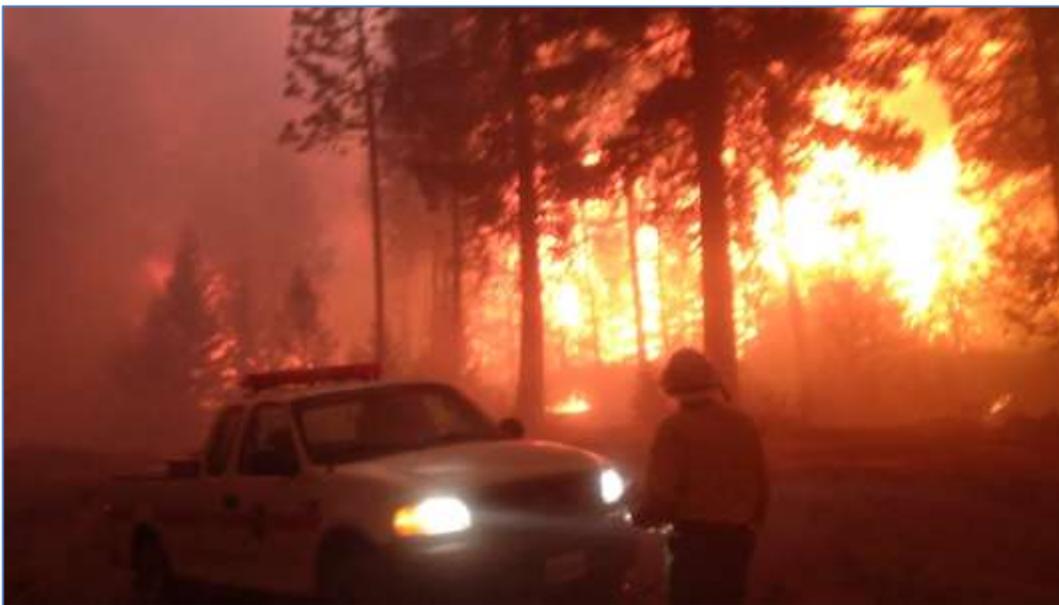
DIVS C holds his fire shelter as the fire advances on their position at 1735 hours.

(This photo was incorporated from the HEQB (t)’s video referenced on next page.)

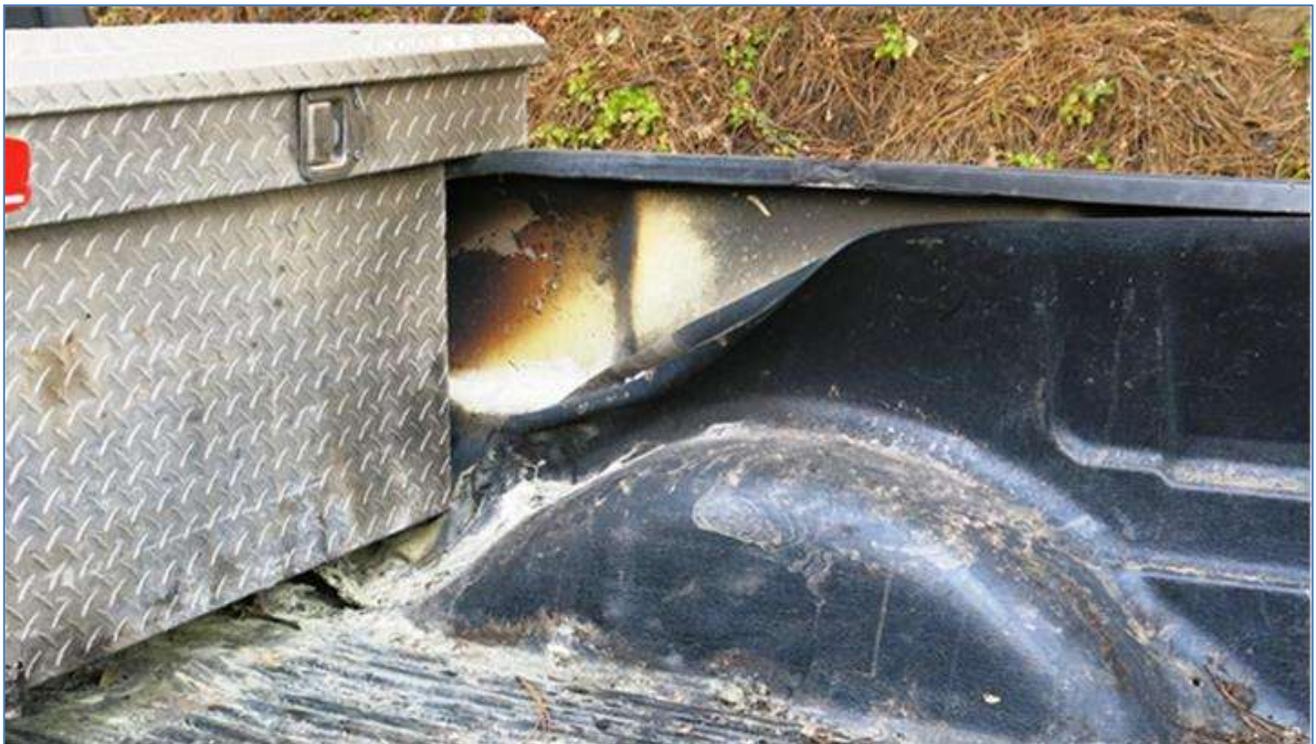
Photos show the fire damage—including melted plastic—that occurred to DIVS C's pickup truck when the contents in the truck bed ignited.
