**SUBJECT :** SAFETY ADVISORY : CACHE MEMORANDUM NO.10-3 - Non Compliant Fuel Bottles

## NATIONAL FIRE EQUIPMENT SYSTEM CACHE MEMORANDUM NO. 10-3

To: NFES: National Interagency Support Caches  
From: Tory Henderson, Chair, Equipment Technology Committee – NWCG  
Subject: Non Compliant Fuel Bottles (NFES 001535, 1 Liter Fuel Container)

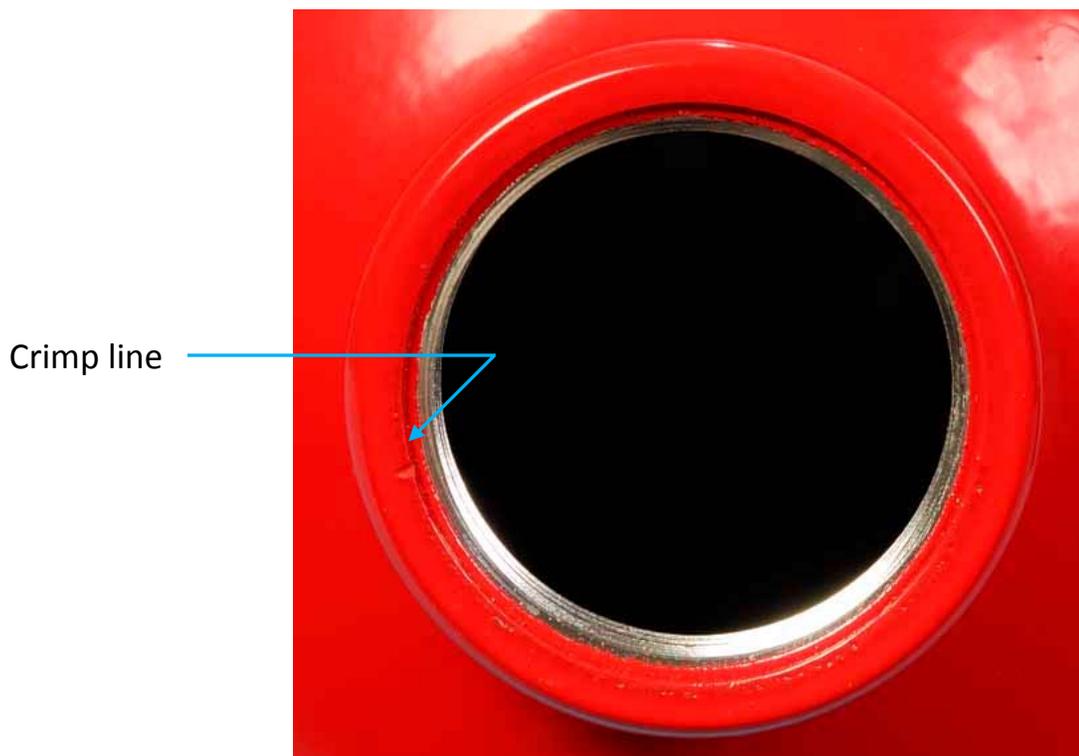
The mouth of a non-compliant two piece bottle showing the threaded insert crimped in place.

It is recommended that all owners of fuel bottles (NFES 001535, 1 liter fuel container, also known as a “Sigg bottle”) inspect their inventory and remove from service all versions constructed with a crimped threaded insert and utilize only one piece construction type fuel bottles.

To check if your fuel bottle is compliant remove the threaded cap and look at the mouth of the bottle. If no crimp is visible the bottle is compliant. If a crimp is visible the bottle is not compliant and should be replaced.

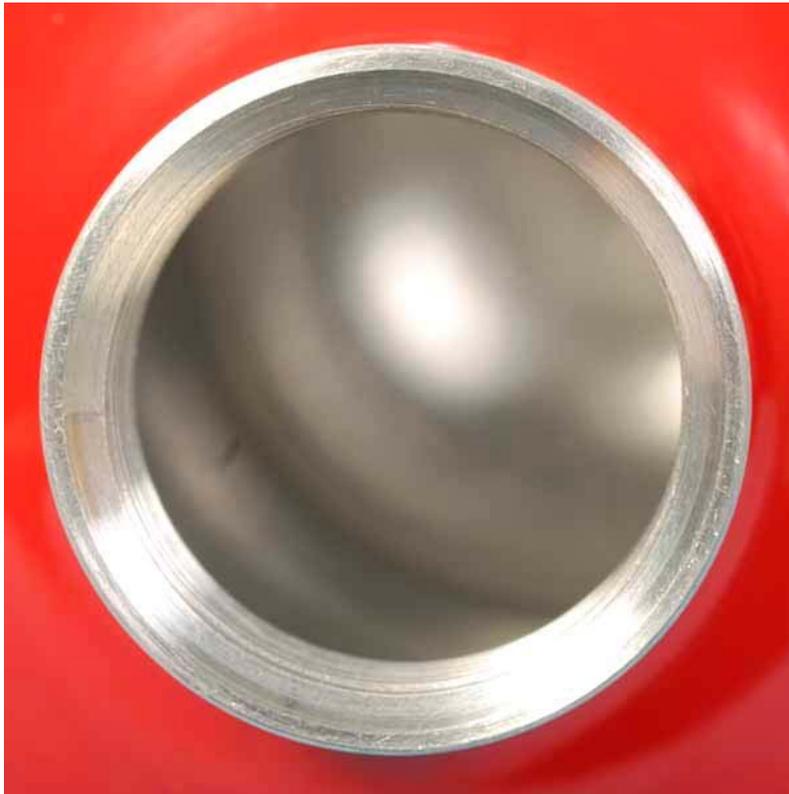
The mouth of a compliant fuel bottle. Note the lack of a crimp line.

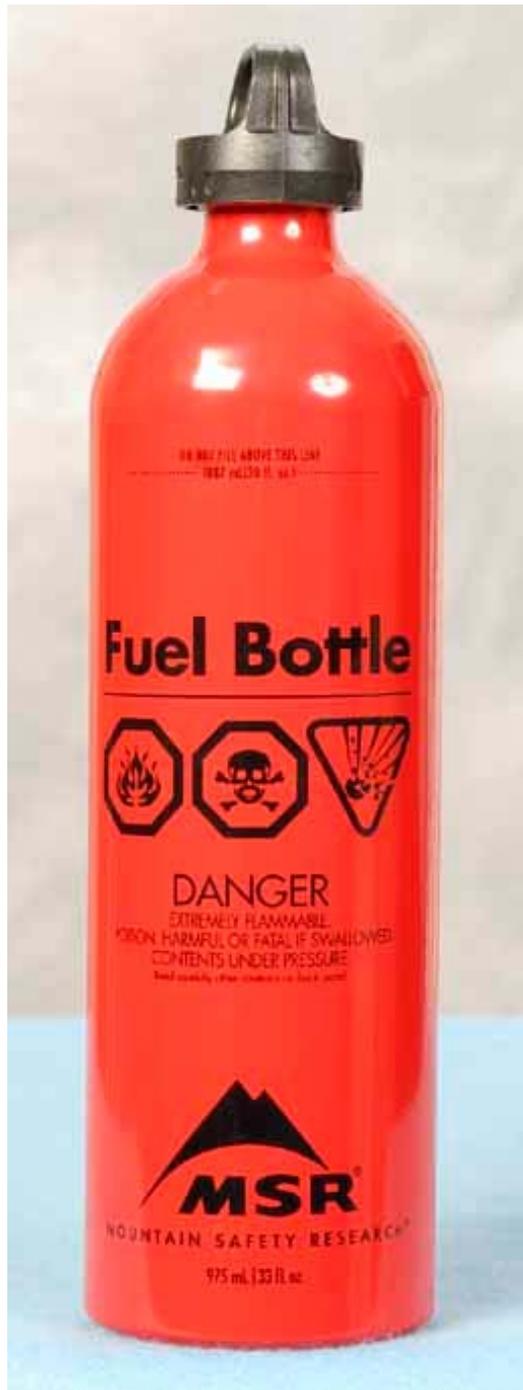
A new style MSR bottle with a childproof cap.  
These bottles comply with GSA requirements

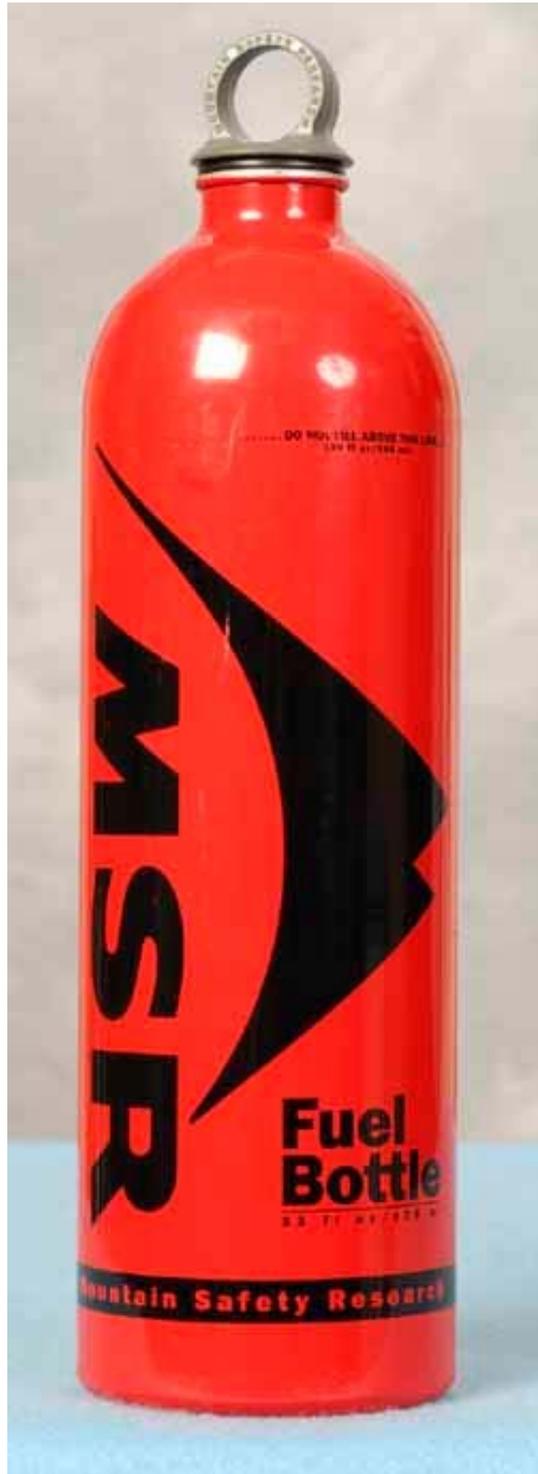
An older MSR bottle that also complies with GSA requirements
